Application of Wrap-Around Reinforced Structure at Hilly Road Repair Case in Thailand & Taiwan

Amie Wang, Nana Chen, Pei Hsuan Wu & Chin Ming Chang
ACE Geosynthetics Co., Ltd. Taichung, Taiwan

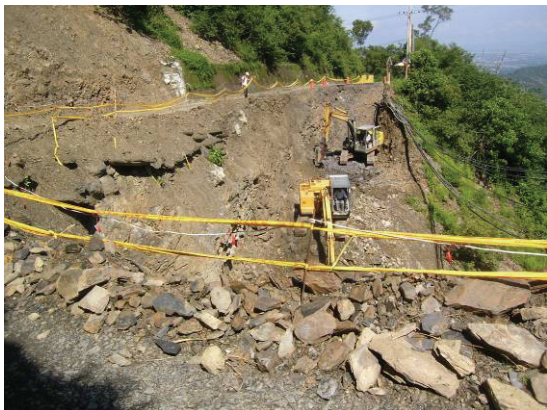
The Project was located in the Country Highway 35 (5k+000), Majia Township, Pingtung County, Taiwan. According to the static from Central Weather Bureau, the accumulated precipitation in Pingtung area exceeded 1,380mm within one month, from 7th July, 2006 through 9th August, 2006, after the continuous typhoon attacks – Ewiniar, Bilis, Kaemi, Saomai and Bopha. Torrential rain brought about subgrade collapse to the two-land highway and caused traffic disruption.

The site investigation data from the design company indicated that the side ditches had suffered from impeded drainage for a long time because of clogging problem. The rainfall brought by sudden downpour overflowed the ditches easily, flowed towards the lower level of slope and converged onto the lower elevation of down slope. After long-term erosion, soil loss occurred at the slope toe and extended to both sides of upstream, causing collapse failure which scouring came up first and it later became headward erosion resulted in traffic disruption. (see Figure 1.)

Figure 1: Case 1 before construction.

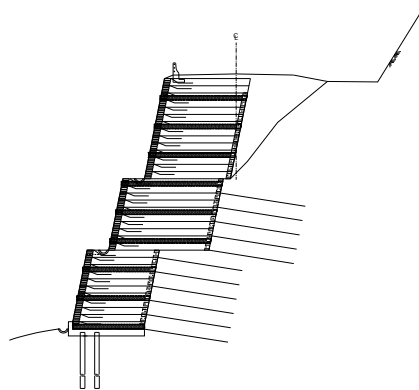
Figure 2: Case 1 design cross section.

According to the drilling report, the soil layer from the top of borehole to depth of 0.8 meters was loose backfill layer, and from 0.8 meters deep extended to the bottom of borehole, 10m in depth, was shale layer - unit weight of 22.9 kN/m^3 , friction angle of 35° , uniaxial compression strength of 300 kPa. The design parameters of backfill soil are unit weight of 19 kN/m^3 , friction angle of 28° and cohesion of 2 kPa. To regain the traffic connection, the design company adopted reinforced retaining wall of height between 16 to 18 meters after considering the conditions that the geology of the bottom of erosion gully was more vulnerable than both sides and construction on hilly road is limited by terrain. Soil nail was designed at the rear area of first and second stages of the retaining wall, the deepest part of the collapse, to avoid slope stabilization problem which may result from inadequate buried length of geogrid in limited site. Meanwhile, micro-piles were furnished in the foundation to enhance sliding resistance of the structure. Lastly, interior and exterior drainage systems were included to complete the design. The construction started from the bottom of collapsed slope by means of reinforcement method layer by layer to the top. When the layer came to expect height, soil nail was set by drilling machine. (see Figure 2. & 3.)

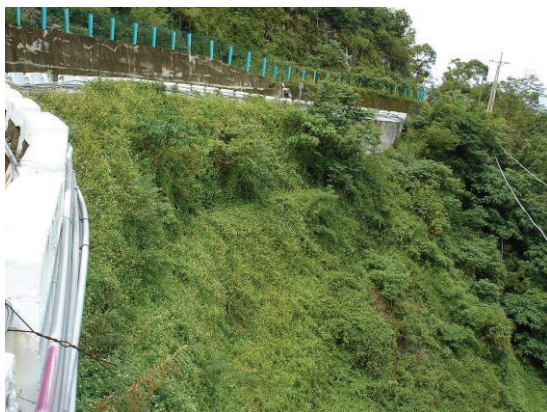
Figure 3: Case 1 after construction.

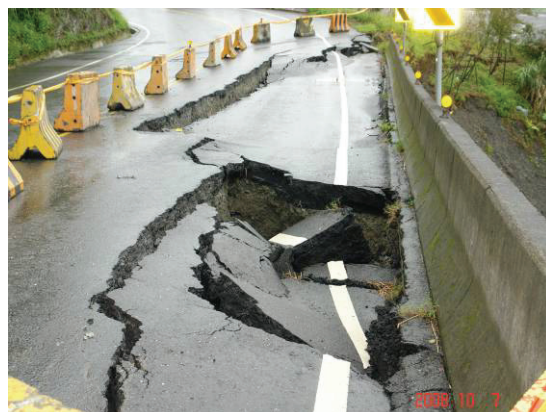
The field investigation stated that Lanyang River was in spate after the torrential rain brought by typhoons. Strong current scoured the foundation of roadway and the scouring of soil at downslope toe led to the collapse of upper roadway. (see Figure 4.& 5.)

Figure 4: Case 2(1k+300) before construction.

Since there was an existing revetment below section 1k+300, the buried length of reinforced material was extended to the rear of the revetment to ensure the stabilization of the whole structure. Part of the revetment was knocked away under the use of temporary retaining structure for proceeding construction. Geogrid GG250-II and GG160-II were proposed to the three-stage reinforced retaining wall, the slope ratio of 1 : 0.3 (V : H), stage height of 5 meters and buried geogrid length of 8 meters.

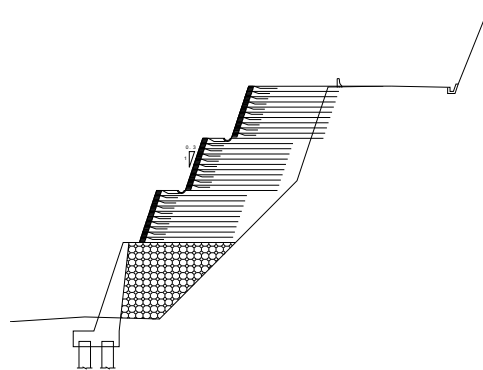
Figure 6: Case 2(1k+300) design cross section.

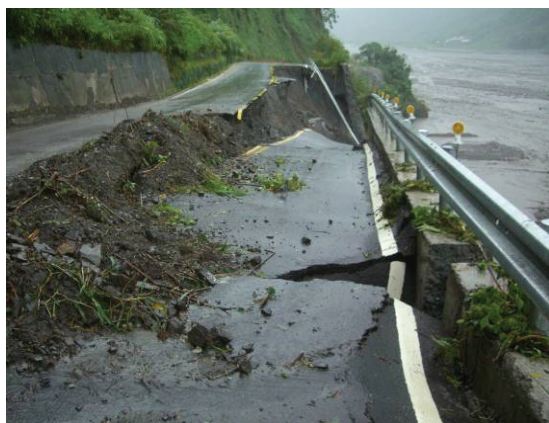
As regards section 1k+500, sliding failure happened to front existing retaining structure. Considering the stabilization of existing slope under construction, 6-meters-long soil nails were driven in the rear of reinforced structure to enhance the stabilization of inherent slope. The vertical and horizontal spacing between soil nails were 3 meters; the offset distance between reinforced slope and front RC wall was 4 meters. To diminish the lateral force of front revetment, the foundation of reinforced slope went deep into 2 meters. Reinforced slope was built with geogrid GG240-II and GG120-II. Its slope ratio was 1 : 0.5 (V : H) and it was divided into five to six stages. Stage heights varied with topography and buried geogrid lengths were 17

Figure 5: Case 2(1k+550) before construction.

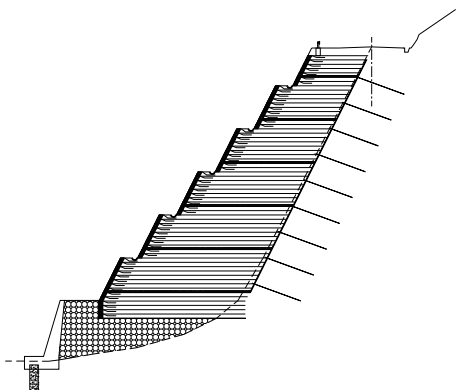
Figure 7: Case 2(1k+550) design cross section.

meters, 15 meters, 13 meters, 11 meters, 9 meters and 7 meters varied with the elevation.

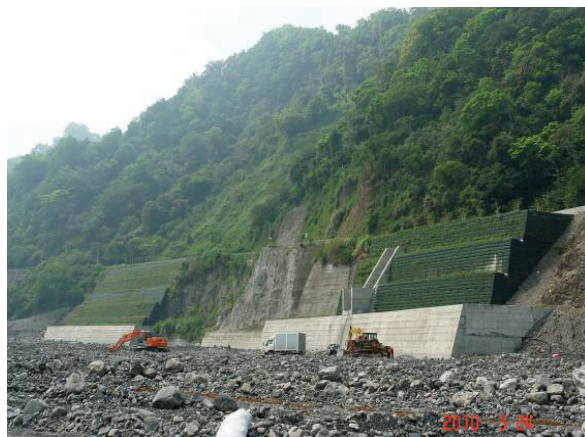
Figure 8: Case 2 after construction.

The design achieved an artificial structure combining safety, excellent drainage and eco-landscape. (see Figure 6. ~ 8.)

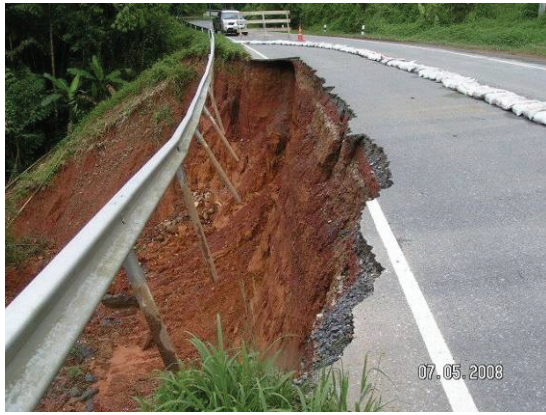
This hilly road repair case was located at Km.8 Ranong-Pato Road, Ranong Province, Thailand. During heavy rainy season, roadway was inundated easily owing to the blockage of ditches. A great deal of rainwater converged and flowed downwards to the slope of roadway, the slope surface was eroded by rainwater steadily as a result of lacking in drainage system. Simultaneously, plenty of water infiltrated into soil layer, leading to the loss of shear strength of deep soil layer and causing circular sliding. Eventually, the roadway upon the slope collapsed, resulting in only single traffic lane was passable subsequently. (see Figure 9.)

Figure 9: Case 3 before construction.

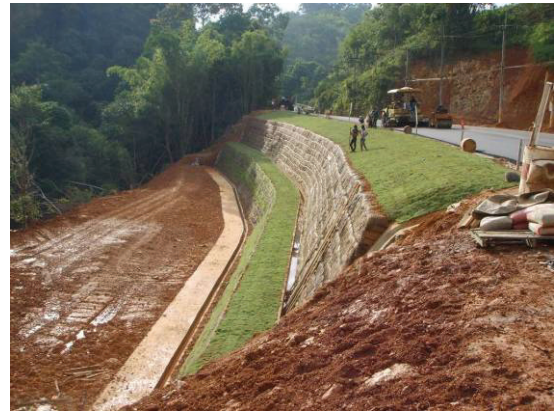
Figure 10: Case3 after construction.

To restore the convenience of transportation, the designer, Department of Highways, adopted reinforced structure - total design height of 8 meters, the slope of less than 70 degrees ($V : H = 1 : 0.5$) - to give consideration to economical and convenient construction method after surveying two factors, the structure to be repaired was downslope of the roadway and the particle at site was sandy soil. Two-stage, each was 4 meters in height, reinforced structure was applied for this repair construction and RC slab was constructed to protect the toe of this reinforced structure. According to stability analysis, geogrid GG100-II was proposed as the reinforced material for this structure and the design buried geogrid length was 3 meters. In order to make the appearance of the reinforced structure go well with

the green surrounding, facing design of wrap-around with piled soil bags was put to use for this construction. Moreover, to prevent the structure from the damage caused by erosion problem due to the lack of drainage system, the designer configured transverse intercepting ditches and vertical gutters respectively as drainage system at the boundary between reinforced structure, RC slab and the surface of original slope.
