# Lessons Learned from Failed MSE Walls

Dov Leshchinsky

**Keywords:** MSE walls, reinforced walls, failures, case histories, geosynthetics

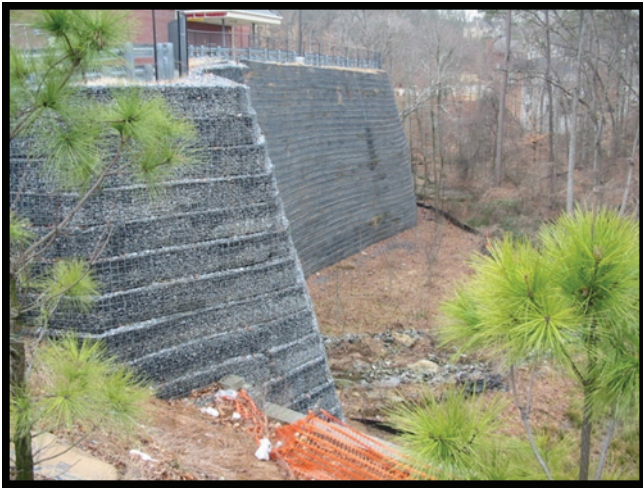
Construction of a geotextile reinforced wall with wire basket facing was completed in late 2001 – see Figure 1. The wall's maximum height was about 16 m; the nominal height of the wire baskets was 45 cm; alternating primary and intermediate woven geotextile layers were placed every 45 cm, corresponding to the wire facing. The backfill in the front 30 cm was clean gravel and away it was random, supposedly with no more than 35% passing sieve 200, compacted to 95% standard Proctor. Following every rainfall, there was significant settlement resulting in major cracks of the drugstore building on top. This was accompanied by soil depression around surface water collectors. The owner filled these depressions with concrete to level the surface with the existing asphalt driveway – see Figure 2. In spring 2003, the drugstore was closed and repairs were done. Repair was massive using anchors (see Figure 3), basically “solidifying” the reinforced soil, costing more than four times the original cost of the wall. The case was settled out of court in summer 2004.

Figure 1: General appearance of the Georgia Wall.

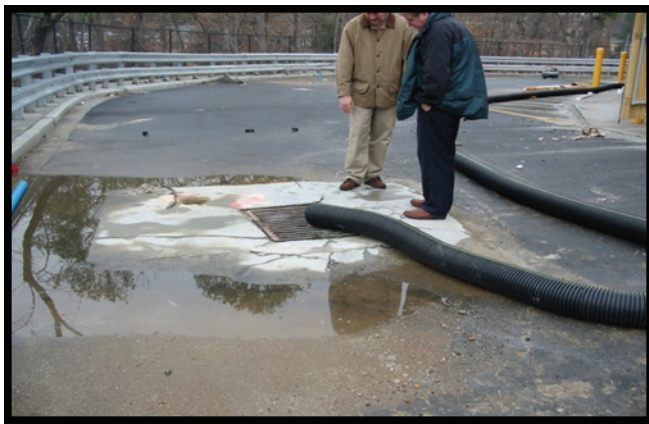
Figure 2: Concrete around surface water collectors to "repair" depression.

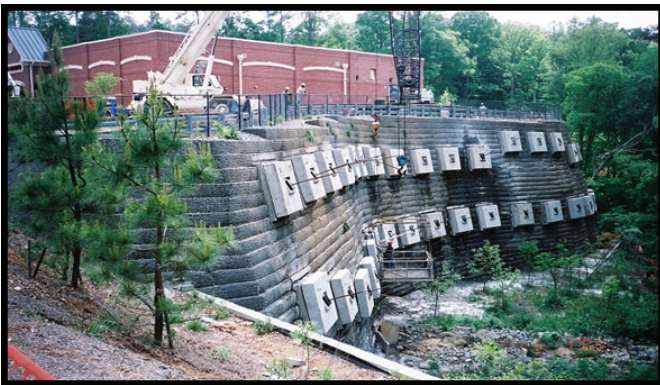
Figure 3: Anchors remedying the problem.

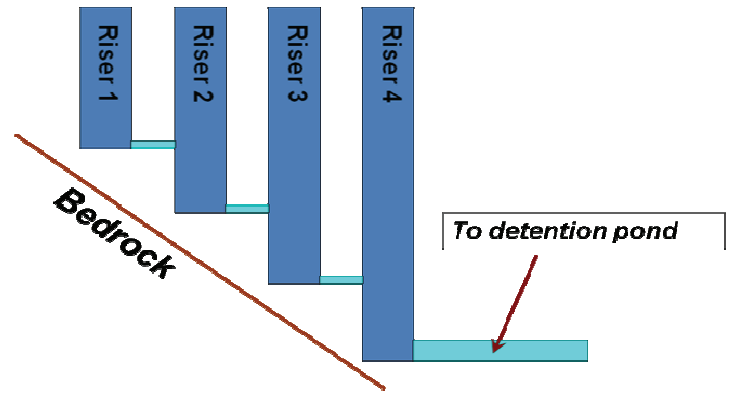
Figure 4: Schematics of risers collecting surface water and connecting horizontal PVC drainage pipes

3. The drainage system consisted of four vertical risers to collect surface water. Each riser was connected to the other by a horizontal drainage PVC pipe as shown in Figure 4. The risers were relocated by the contractor into the reinforced soil area (from the original plan placing it in the retained soil zone) since it was 'easier' to construct. The depression occurring around the risers clearly indicates that the soil there was poorly compacted.

1. Generally, the backfill was poorly compacted. SPT implies it was less than 90% standard Proctor (95% was specified).
2. Poor compaction around the risers resulted in differential settlement around the risers shearing the PVC horizontal pipes connected to the risers. Video inspection confirmed this conclusion. As a result, the surface drainage system worked in reverse; the water it collected was fed into the loose reinforced soil. The end result was in-service compaction, an unacceptable situation.
3. Piezometers indicated porewater pressure of about 3 m. Global stability for this situation indicated a factor of safety of about 1.1. Such low factor of safety is typically associated with large deformations. Clearly, this is an unacceptable value.

4. As much as possible, drainage system should not be placed within the reinforced soil. Otherwise, if it fails, the wall is likely to fail as well. Reinforced backfill is not designed to serve as a water carrier. Furthermore, there is no simple repair of a drainage system embedded within the reinforced soil. Hence, redundancy in drainage is good. Cost of repairing failure is nearly always more expensive than the “saving” derived from poor construction or design.

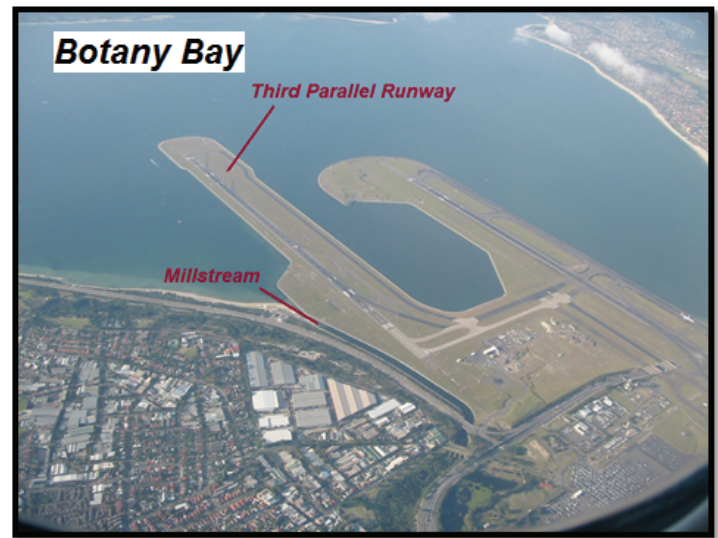
Figure 5: Overview of the 3<sup>rd</sup> Parallel Runway.

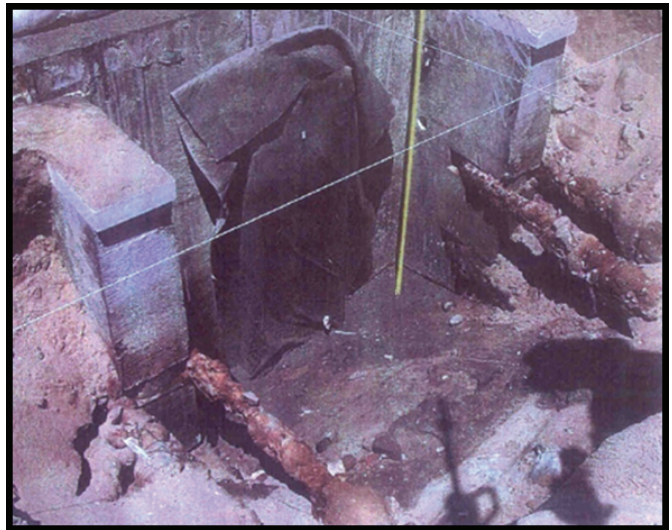
The contractor has guaranteed maintenance-free performance of 100 years for the seawall and 50 years for the Millstream wall. Two years after construction sinkholes appeared next to some joints. In about 2002, 30% of the joints had significant sinkholes – see Fig. 7. Infilling these holes with sand could not resolve the problem. Such sinkholes accelerate corrosion – see Fig. 7. Repair was done between 8/2005 and 9/2006. Jet grouting was used from the back of the face to the rear of the reinforcement. That is, in essence a gravity wall, 9 km long with widths up to 5 m, was formed thus rendering the joints and reinforcement unimportant.

Figure 7: The problem: Sinkhole at ~30% of joints.

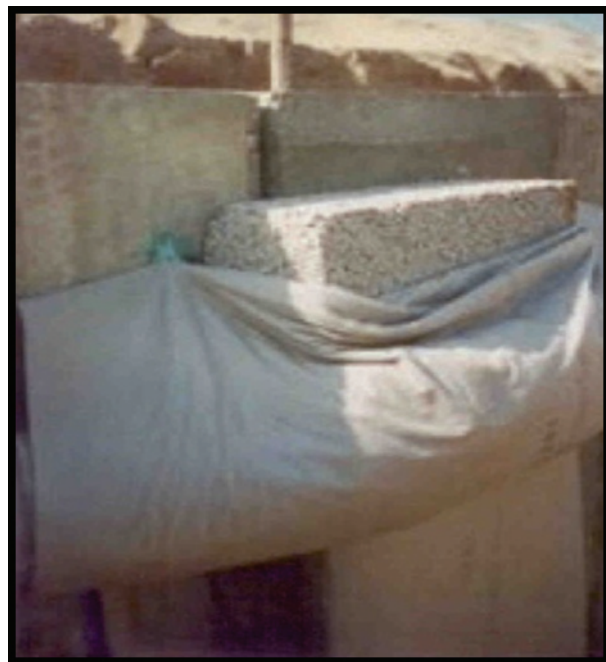
no-fines blocks were stacked against the joints and then nonwoven geotextile with  $AOS < 80 \mu m$  was glued at spots to the panel on either side – see Fig. 6. The blocks allowed passage of particles smaller than #200, should such particles pass the geotextile. The no-fines blocks were presumably placed to break water energy under wave action. Construction started in 1992 and completed in 1994, 9 months ahead of schedule.

Figure 6: Facing Panels: Joints protected by no-fines blocks and nonwoven geotextile.

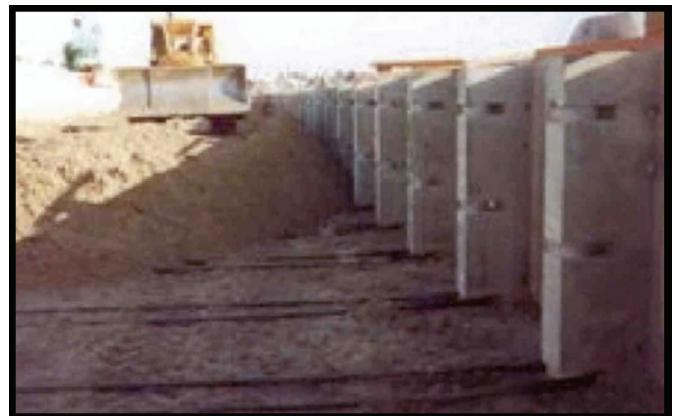
Figure 8: Back of Double-T Panels: Metallic strips connected to concrete buttresses (part of the concrete panels), and placement of 660 mm thick layer lift.

1. The designer specified maximum 330 mm layer lift for compaction. The contractor actually used layers lift of 660 mm (generally, the vertical space between reinforcement layers). The reason for the increase was to “ease construction.”

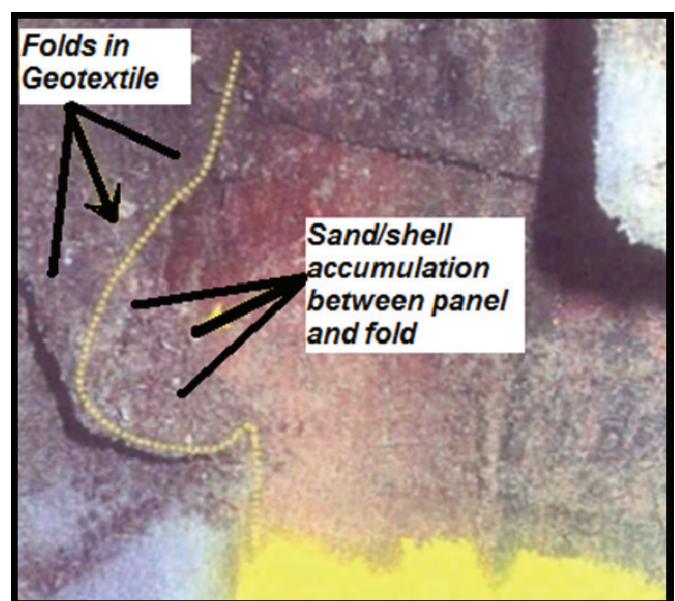
Figure 9: Folds in geotextile with sand/shell accumulation allowing sand to “flow” from the retained sand to the seaside through the joint .

4. Excavations at some locations where sinkholes occurred clearly showed that the geotextile had folds filled with coarse sand and shell particles. These folds extended between the retained sand and the open joint. Slowly but surely, aided by tidal fluctuations and wave action, retained sand could escape into the seaside of the wall hence producing sinkholes – see Fig. 9. Such folds in marine environment serve as ‘highway’ for sand flow. It is noted that folds filled with sand/shell were observed below the low tide thus implying that the formation of folds had nothing to do with wave action or tidal fluctuations. Its formation was likely due to poor construction.

5. Folds were formed by the downdrag force occurring as the sand moves down relative to the geotextile. If the sand is loose, it will compress in-service under tidal fluctuations. Alternatively, folds could have formed during compaction, as at the face it was not done consistently using light weight compactors, thus occasionally dragging the geotextile down and creating folds. In fact, sinkholes occurred at only 30% of the joints. Random quality construction usually will lead to random results and performance.
