Cyclic drawdown of water causing the slope failure of canal and dam

Suttisak Soralump¹, P.W. Noppadol², K. Panthi³ and J. Sanmuang⁴

1 INTRODUCTION

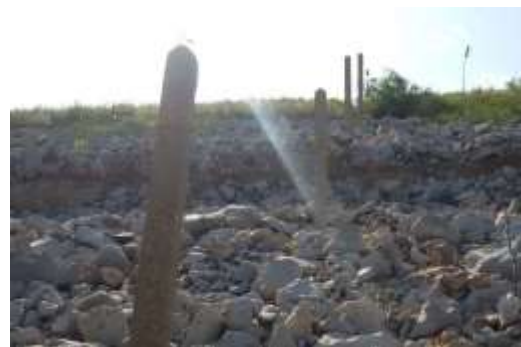
since the filling of dam is shown in Figure 3. It can be seen that the dam had experience several sudden drawdown before the observation of slope movement but no movement was observed prior to 2014. The fastest drawdown rate was 10.76 m/day and the largest drawdown distance is 24.33 m. Figure 1 shows the photo of the movement on the dam slope and this movement increased each year with the decrease in water level.

Figure 1: Photograph showing the movement of Pa Bon Dam after first movement

Couple stress analysis reveals that the factor of safety of slope start to reduce significantly when the reduction of water level was substantial. After that the slope started to move each year even though the drawdown rate and distance was smaller than previous year. Residual soil strength testing was carried out from

(Chen, Zhang, & Chan, 2018). The accumulation of shear strain was found to be directly proportional to the height of drawdown. Following the movement each year, upstream berm were designed to reduce the slope movement as shown in Figure 2. In a mean time, the reservoir water level is controlled and maintained at higher level until the dry season.

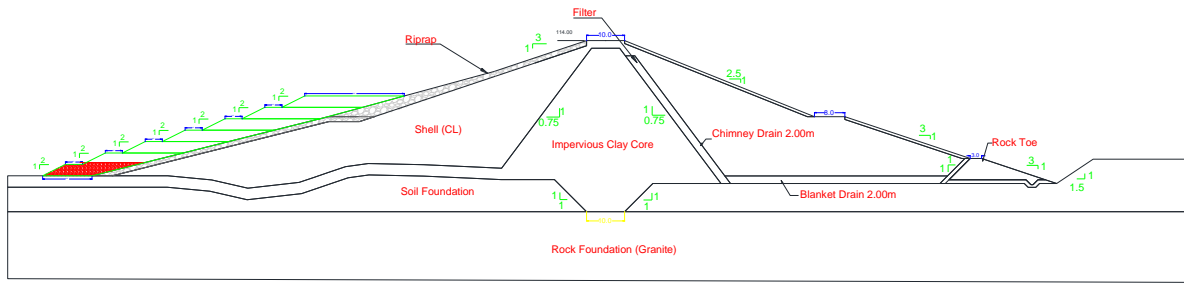
Figure 2: Cross Section of Pa Bon Dam

Pa Bon dam is a zoned dam located at southern part of Thailand. The typical cross section of the dam is shown in Figure 2. The operation of the dam started in 2004 and was operating without any hindrance until the year 2014 when the first movement was observed in the slope of embankment structure. The dam was operated after minor rehabilitation but it continued to move each year with drawdown of water. The actual water level

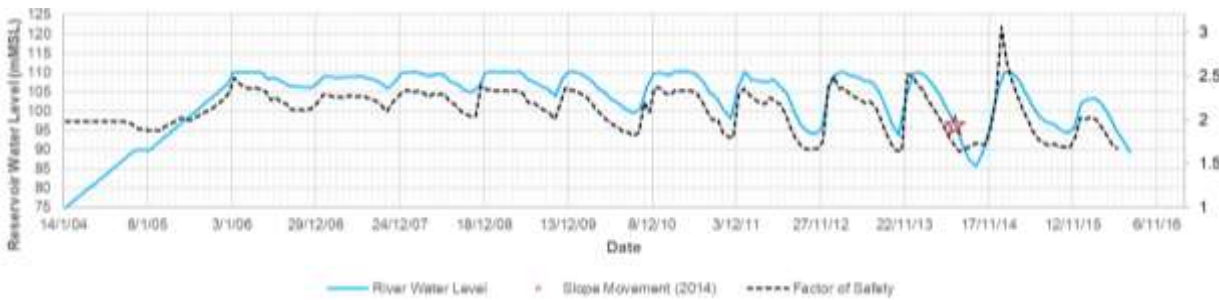
Figure 3: Variation of Safety Factor with Water Level of Pa Bon Dam

collected dam material (Head, 2011; Mesri & Huvaj-Sarihan, 2012; Stark & Hussain, 2010). Slope stability analysis showed that the factor of safety decreased with decrease in water level but no failure was obtained analyzing the slope at peak strength (Figure 3) hence, the analysis was based on the assumption that the strength of dam material had reached the residual stage due to cyclic loading of water leading to the movement of the slope. The shear strain with passage of time was calculated for the soil after reaching the residual state using both Mohr Coulomb and Modified Cam Clay Model as shown in Figure 4. Strain softening behavior leading to progressive failure on embankment has been successfully determined by using MCC model (Chai & Carter, 2009) .

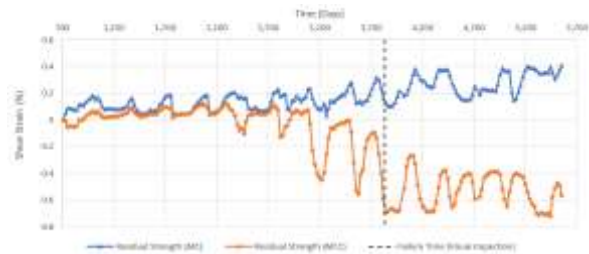
Figure 4: Shear Strain with Passage of Time for Pa Bon Dam (MC and MCC model)

It can be observed that the shear strain was accumulating with the passage of time and has been the cause for the reduction of shear strength. This result resembled to the numerical analysis and laboratory test conducted for the samples of three gorges dam

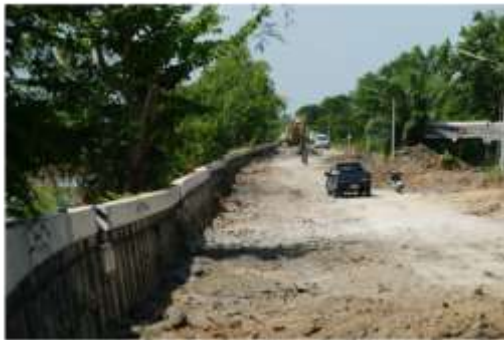
Statistically, it is observed that every certain year there is the failure of canal slope. Even though there are

several possible causes of failure, on the basis of information available, it was hypothesized that the failure had occurred due to sudden drawdown of water due to prolong drought. The fluctuation of water level in canal is presented in Figure 9.

Figure 7 : Failure of embankment along Canal Bank

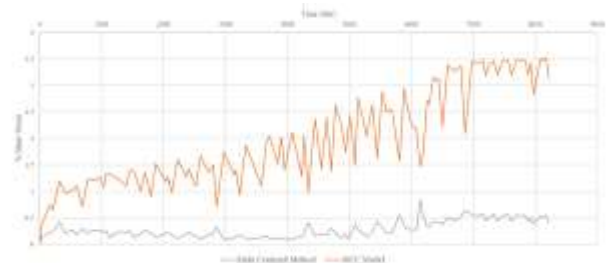
as well. The slope stability analysis in this case too showed the fluctuation of safety factor with water level but no failure was obtained analyzing the slope in peak strength (Figure 9). The shear strain was calculated for the slope using both MC and MCC model and it showed that the shear strain was accumulating with passage of time. The accumulation observed in MCC model was very significant as compared to MC model.

Figure 8: Shear Strain with Passage of Time for Pa Bon Dam (MC and MCC model)

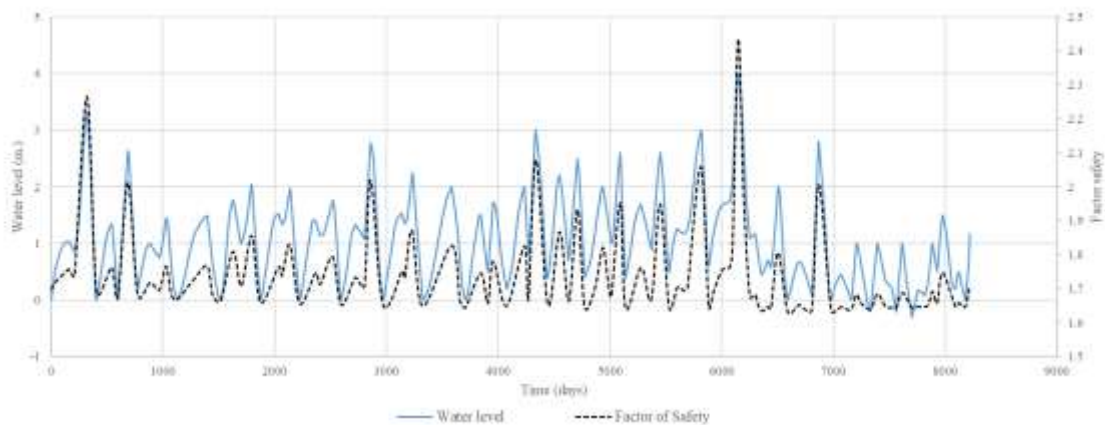
Figure 9 : Figure showing the variation of safety factor with water level with passage of time

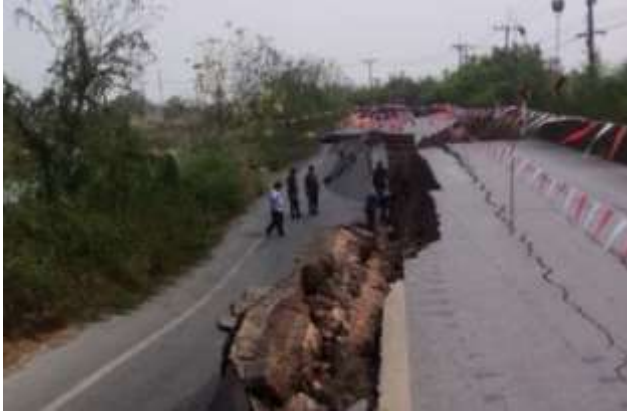
The movement of the slope was also observed at the different section of the canal. The behavior of the soil was tested in centrifuge model (Figure 11) with actual variance of the water level (Sasingha & Soralump, 2017) . The failure of the slope is shown in Figure 10 . After the slope movement, test was conducted by using the pile and without the use of pile. It was found out that the pile can be used for the stabilizing the slide slope

Figure 10: Failure of Road Along the canal (Sasingha & Soralump, 2017)

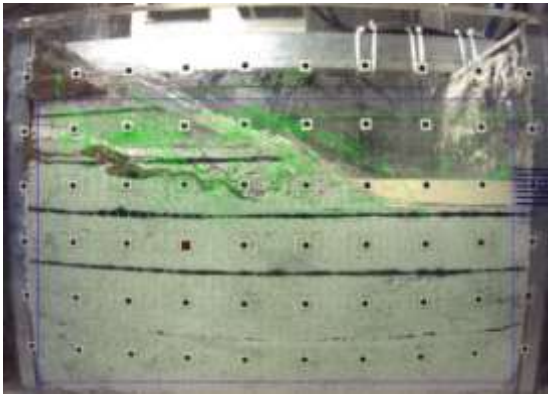
Figure 11: Photo of centrifuge testing to simulate the effect of repeated drawdown

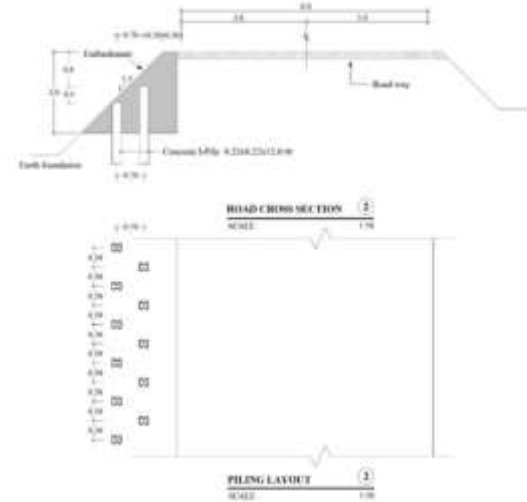
Figure 12: Reinforcement of Slope using Short Wooden Piles

1. Increase the required FS during the design for the case of sudden drawdown. This methods helps in minimizing the strain movement in each drawdown cycle.
2. Strengthening the slope can be carried out by the use of piles (He, Hazarika, Yasufuku, & Han, 2015). This has been successfully done in many road along the irrigation canal in soft Bangkok clay area. Short wooden piles were used to reinforce the slope and reduce accumulation.
