## Static and seismic performance of Mae Suai dam and its remedial works

Suttisak Soralump

Associate Professor, Dam Safety Research Unit, Geotechnical Engineering Research and development center,

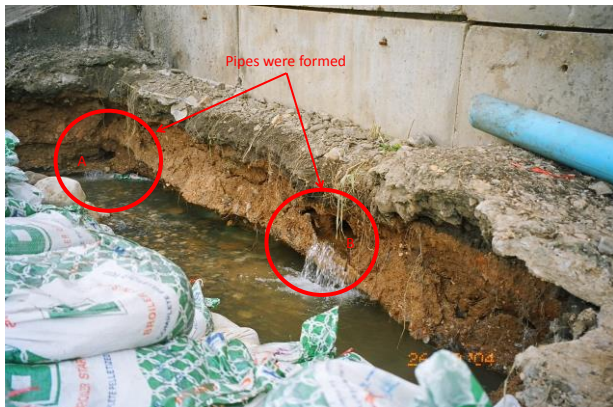
In 2004, after opening for service in 1 years and the water overtopped the spillway, the leakage has been observed at the downstream crest near the contact area between the earth zone part and the RCC part. The water flows out behind the RCC block and appeared to be clear. The leakage could be observed if the reservoir elevation reaches a certain elevation near the crest of the dam. The maximum flow rate was 1.5 cubic meters per minute with the approximated head water of 1.2 m. Fig 4 shows the photos of the leakage.

Figure 5 The photos of the leakage

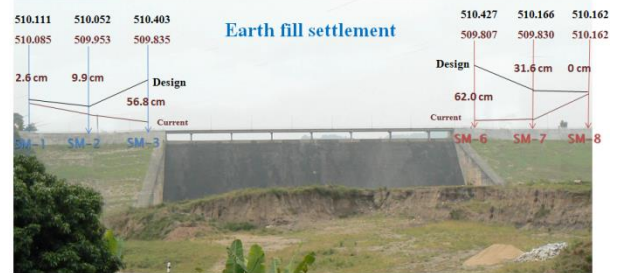
Visually, it can be seen that there is a differential settlement between earth filled section and the RCC section. The settlement of the RCC section is approximately 0.18% of its height and the earth filled section is nearly 1% (Fig 5). Even though the differential settlement has been expected but the leakage is unplanned. The investigation done by RID found the crack in the RCC block and opening of RCC lift joints. Theses may contribute to the leakage (Fig 6). Another possibility is the seepage of the water under the RCC block. The repair work has been done by installing the impervious membrane over the surface of RCC blocks as shown in Fig 7. The repair work seems to be effective in reduction the rate of leakage flow but some leakage still persisted. The water filtering and collecting system then installed at the leakage

Figure 5 The settlement of the RCC section and earth fill

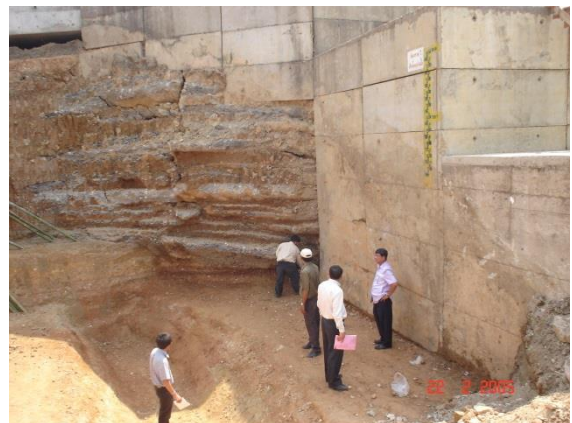
Figure 6 The crack in the RCC block and opening of RCC lift joints

5.1 Different settlement causes the lift joints open and crack to the RCC block may lead to the concentrated leak of the dam.

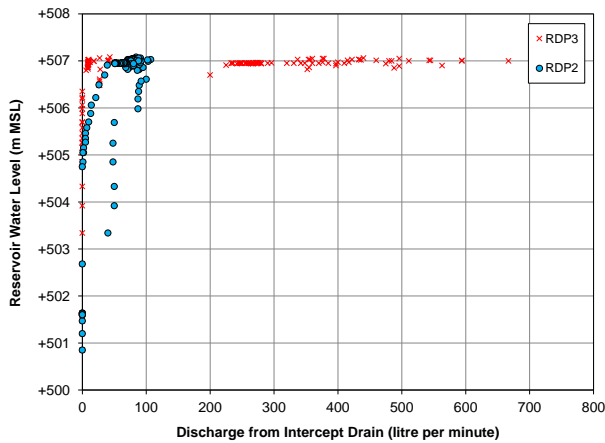
area to prevent the unnecessary seepage erosion that might form piping failure (Fig 8). However, it is found that, at the same water elevation, the rate of leakage is increasing every year which indicated suffused flow (Fig 9).

Figure 9 The discharge from intercept drain

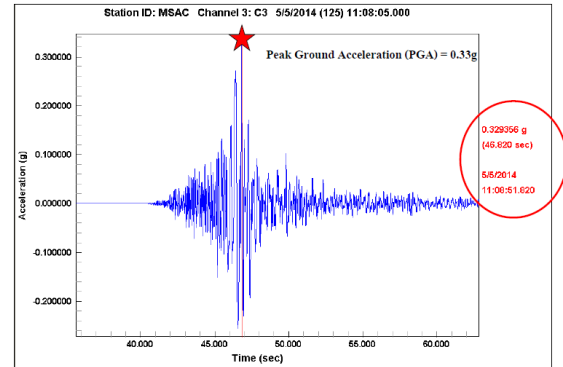
On the 5<sup>th</sup> of May 2014, the 6.3 magnitude earthquake occurred in Chiang Rai province. The epicenter to the dam site is 18 km. However, the epicenter of the aftershock is closer to the dam site. The dam experienced the strong ground motion and the accelerometer at the right abutment recorded the maximum PGA of 0.33g (Fig 10). The dam performed well. There is some crack observed in the concrete cover of the RCC block on the crest of the dam. The crack is much above the maximum water elevation, therefore the safety is not to be concerned. Especially, the RCC block that seen some cracks is the part that not related with the stability of the dam.

Figure 10 The measured peak ground acceleration at right abutment [2]

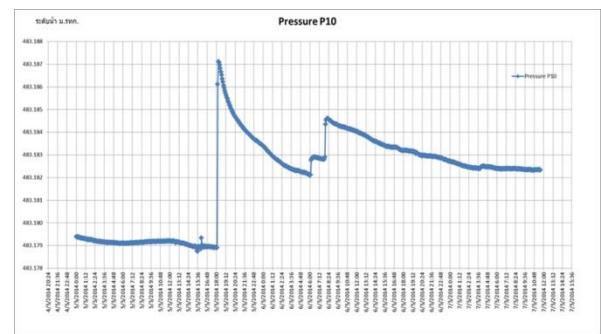
The piezometric values in the impervious core and the foundation increased at the time of the main shock and

responded most of the time to the strong aftershock. However, the piezometric values are still under the safety limit (Fig 11).

Figure 11 The piezometric values in the impervious core at the time of the main shock and strong aftershock
