Technical Paper

Assessment of the upstream slope failure of a dam due to repeated cyclic drawdown

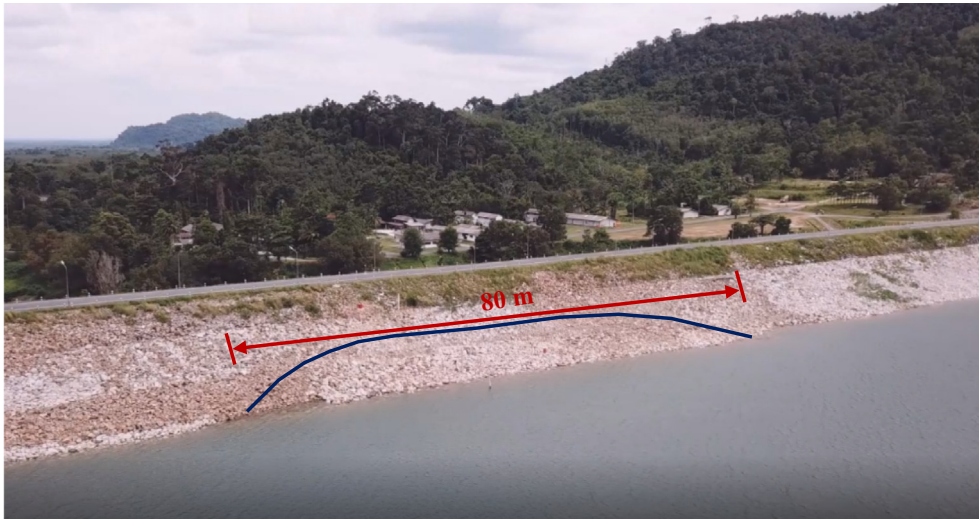
Operation of the Khlong Pa Bon Dam began in 2004. On June 27, 2014, physical movement was observed at the upstream slope in three locations: 0 + 272, 0 + 297, 0 + 332 m and their vicinity (Fig. 2), and this movement has continued to the present date. The movement started from a higher elevation and is currently moving toward the dam toe. As the slope has continued to move each year since 2014, there is great concern regarding the safety of

Fig. 2. Observation of a crack at the upstream slope of Khlong Pa Bon Dam (Royal Irrigation Department 2016).

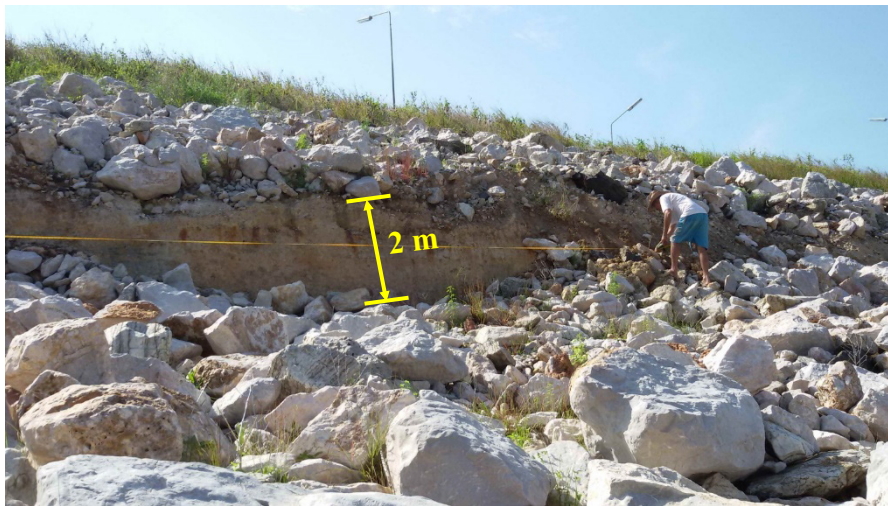
Fig. 3. Physical measurement of the upstream slope after the first movement (Royal Irrigation Department 2016).

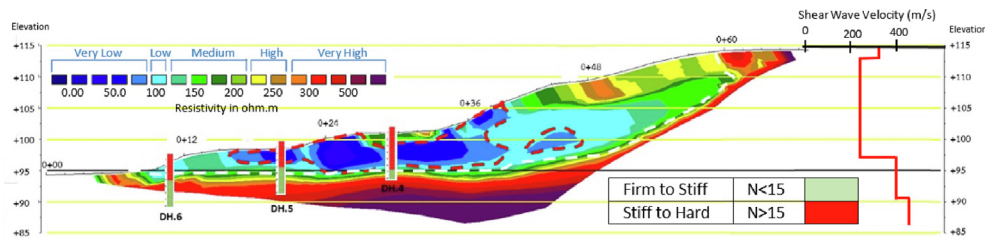
was approximately 200–400 m/s (Fig. 5), indicating that the embankment structure consisted of compacted soil layers. There was no significant difference between the results at the test positions near the area of movement and those outside the area of movement.

Fig. 5. Comparison of the results of resistivity tests, SASW, and borehole investigations (0 + 297 m).

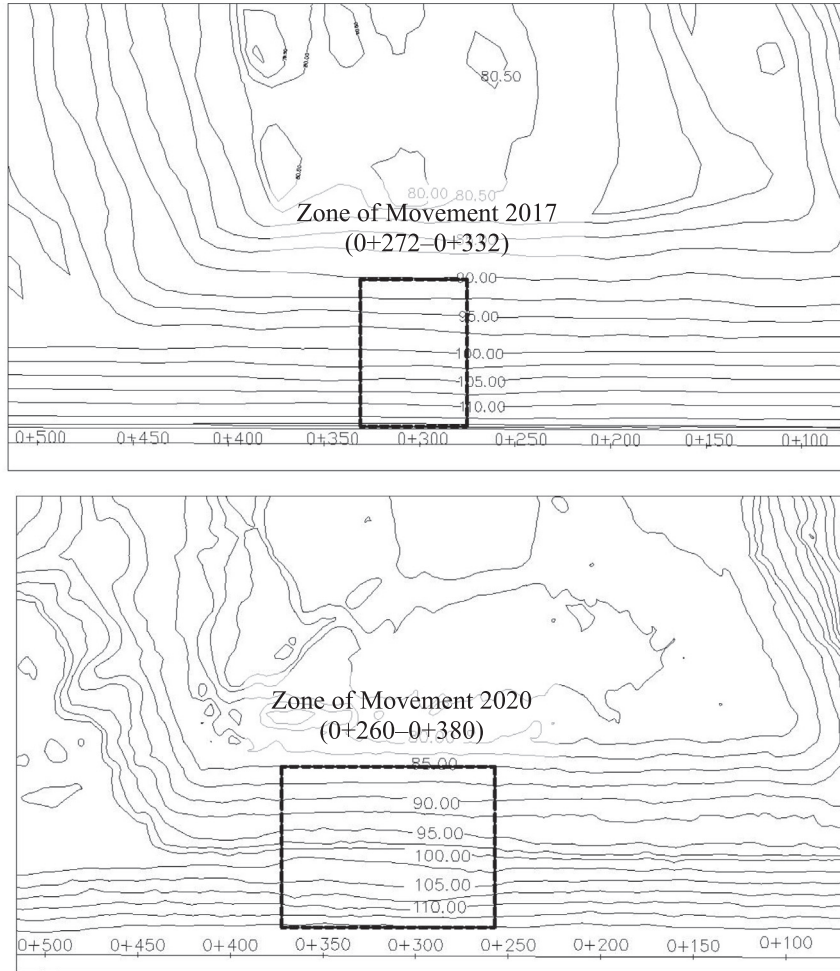
Various site investigations were performed after the slope movement in 2014. Borehole investigations with depths of 8–10 m were carried out at the failure zone (i.e., 0 + 272 m, 0 + 297 m, and 0 + 332 m) in 2014, followed by another investigation near the toe zone in 2017 (Panthi and Soralump 2020). The probable failure surface identified from the borehole investigation is marked by the red section in Fig. 5. Similarly, echo sounding was conducted to investigate the extent of the slope movement in 2017 and 2020. The movement was observed from 0 + 272 m to 0 + 332 m and the vicinity in 2017, while movement from 0 + 260 to 0 + 380 m was observed in 2020, indicating that the failure section has been increasing each year (Fig. 6).

Fig. 6. Zones of movement identified using echo sounding (2017 and 2020).

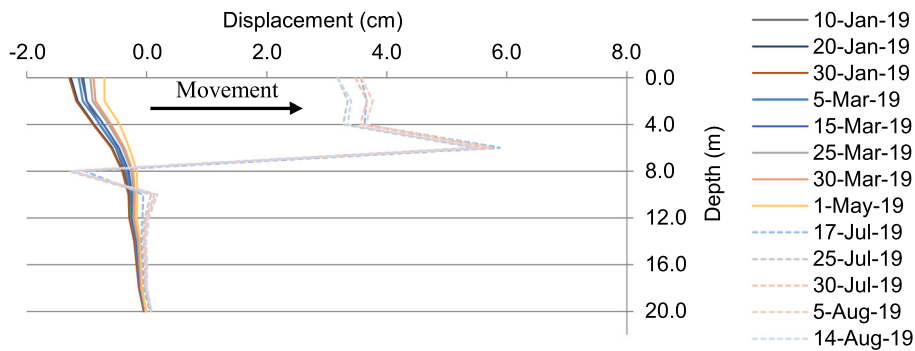
ters were installed in December 2018 to observe the in situ movement of the upstream slope. There was no movement in the upstream slope with decreases in the water level until early May 2019, but movement was observed beginning in July 2019 when the water level was lowered by 5.5 m from the initial condition (Fig. 4 and Fig. 7). It was found that the observed movement was a continuation of the previous slope movement. The failure surface estimated from the various site investigation results is shown in Fig. 8.

Fig. 7. Inclinometer results (IN4) at the Khlong Pa Bon Dam (Dec 15, 2018 to Aug 10, 2019).

The in situ results obtained from the inclinometers showed that the upstream slope started moving in 2019 when the water level was lowered by 5.5 m (Fig. 7). Similarly, the slope stability analysis using the residual strength parameters also showed that the FoS was less than 1 when the drawdown elevation was less than 105 m from MSL (5 m in the case of Khlong Pa Bon Dam). Therefore, the results obtained from the inclinometer and slope stability

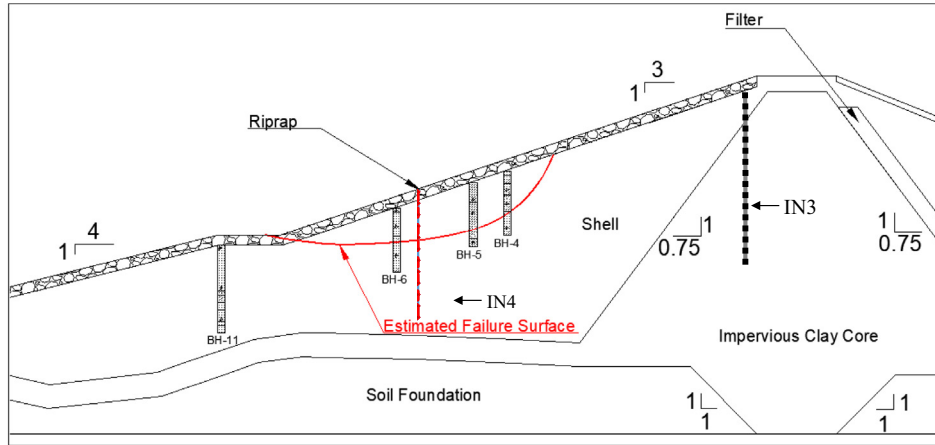
Fig. 8. Determination of the failure plane from site investigations.

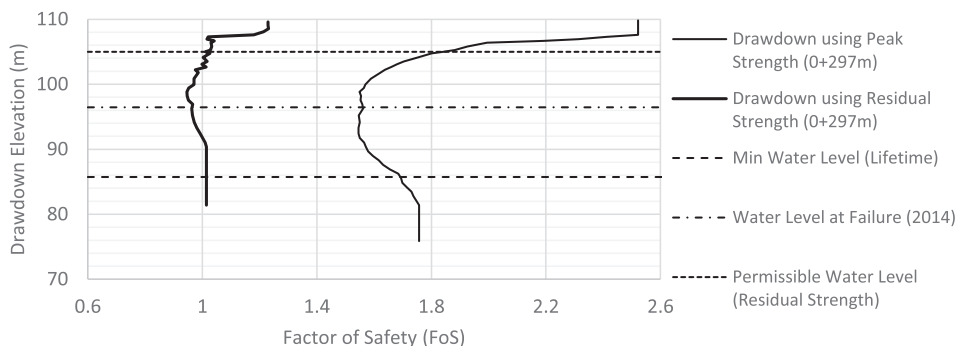
The relationship between the drawdown of water levels and FoS is shown in Fig. 15 for the peak and residual strengths. The FoS initially decreases with the decrease in water level, then remains constant after a certain drawdown elevation, and finally starts to increase again. The characteristics of the relationship between the drawdown elevation and FoS are consistent with the results obtained in previous research (Zheng et al. 2009). At the failure zone, the FoS was minimum when the water level ranged from 92 to 98 m. This is termed the critical range of the water. The upstream slope movement in 2014 was observed when the water level was within this critical range (Fig. 15).

Fig. 15. Variation in the factor of safety with the drawdown level based on the peak and residual strengths.

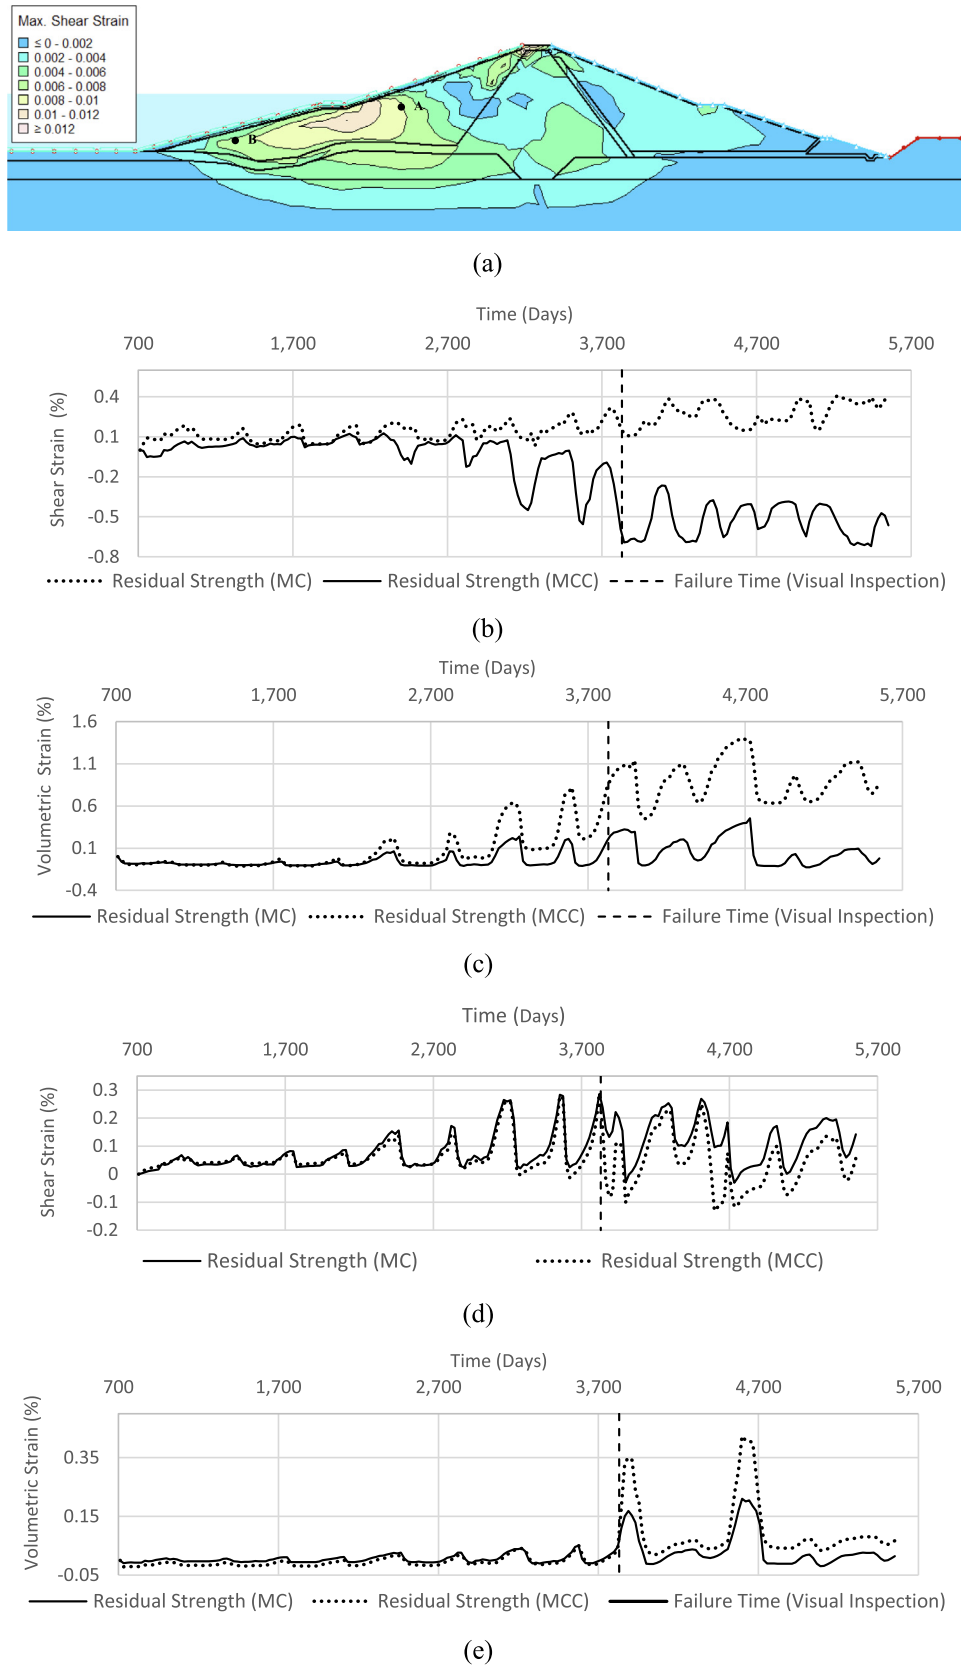
Fig. 18. (a) Maximum shear strain contours of the dam section at 0 + 297 m at 3820 d; (b) shear strain time history curve at the failure zone (Point A); (c) volumetric strain time history curve at the failure zone (Point A); (d) shear strain time history curve at a non-failure zone (Point B); (e) volumetric strain time history curve at a non-failure zone (Point B).

The maximum shear strain contour of the dam section at 0 + 297 m is shown in Fig. 18(a), where point A is located in the zone of movement and point B is located in a zone where no movement was observed. The values of the shear and volumetric strains were normalized after the first impounding. In the failure zone, the MC model showed an increase in both shear and volumetric strain with the drawdown of water, but the original state was reached after one complete cycle (Fig. 18(b) and (d)). In contrast, an accumulation of both volumetric strain (1%) and shear strain (0.7%) was observed in the MCC model (Fig. 18(b) and (d)). The results obtained from this model are consistent with the experiments conducted by Chen et al. (Chen, Zhang, and Chan 2018). Likewise, no major accumulation of shear or volumetric strain was observed at Point B (Fig. 18(c) and (e)) with either model because the zone was always saturated and was less affected by the water level fluctuation. It was found that the fluctuation of the water level was directly proportional to the accumulation of shear and volumetric strain. The results also show that the MC model cannot determine the softening behavior of the slope; therefore, the current design standard in Thailand cannot ensure the safety of the embankment slope.

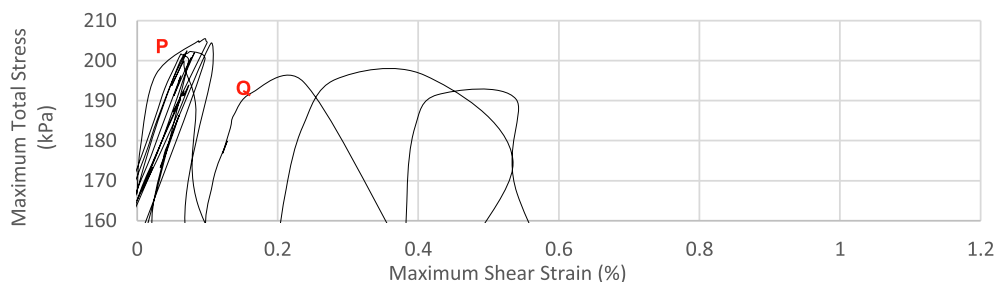
The stress–strain curve was also plotted at the failure zone to investigate the behavior of the upstream slope with fluctuations in the water level (Fig. 19). The plot of the

relationship between the maximum total stress and maximum shear strain was obtained from the numerical model at point X (Fig. 14). The results show that the upstream slope was in the elastic phase from 2004 to 2010 (Point P) because the shear strain returned to its original state after each drawdown cycle. However, after 2010, the soil surpassed the elastic phase, leading to the accumulation of shear strain (Point Q). With each additional drawdown cycle, the strain accumulated, causing movement of the slope in 2014. The strain–time history curve shows that the strain began to accumulate (Fig. 18) when the drawdown factor was greater than one (Fig. 16).

Fig. 19. Stress–strain curve at the failure section (Point X) for Khlong Pa Bon Dam.
