Integrating Solution for Road Slide Repair, Northern Part of Thailand

ABSTRACT: The 2-lane highway route number 1004 was the major road to Phrathat Doi Suthep temple and pagoda, landmark of “Chiang Mai”, the significant province of northern Thailand. Part of the road was eroded and slide since steep of side slope road to mountain. At Km.12, the road was eroded of side slope through back slope of lower road that may become slide failure in the future. The method of solving was constrained by high traffic and limited width of area. The integrating solving method by using Soil nail and Geogrid reinforced slope during and after construction, pile foundations was applied for firm bearing conditions and indefinite layer of soil foundation. Erosion control mat was applied to prevent surface erosion in the future and long life structure. The post benefit after construction was the widening road as 3-lane traffic service safety.

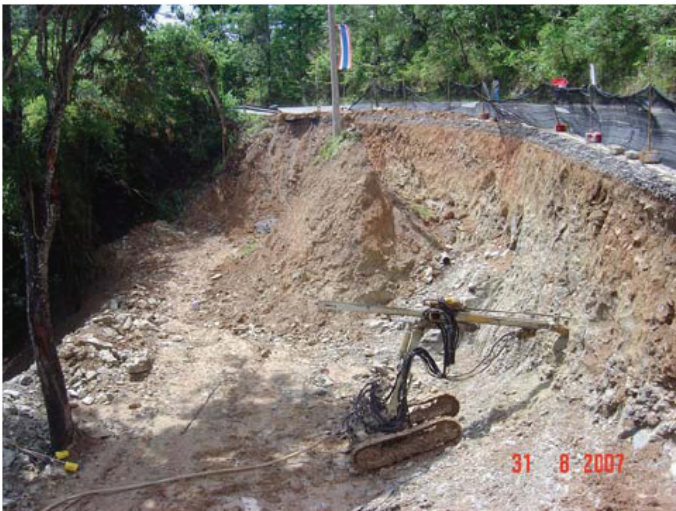
Figure 5: Soil nail construction.

First step, problem of soil movement when excavated had to be solved. 5-m length of soil nails were used of every 1.5 m. x 1.5 m. to stick vertical existing soil during excavation for repair construction.

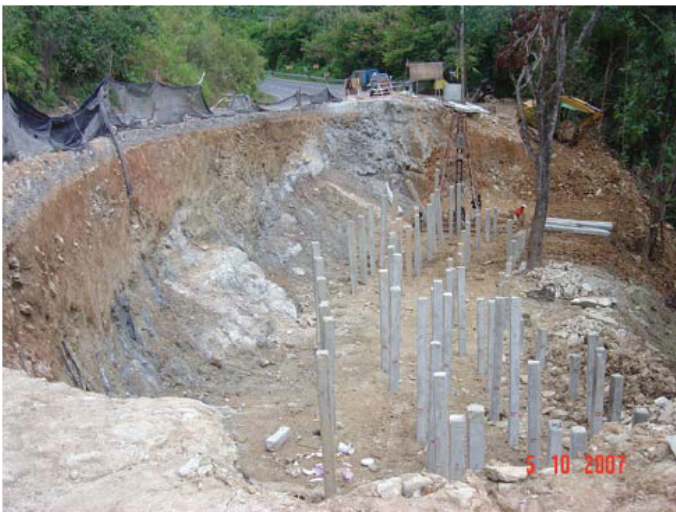
Figure 6: Piles construction.

Second step, the unknown soil properties and profile had to be solved. Piles and footing had to be used for solving this problem. 6-m length piles had blown to find the firm layer of soil. Then raft footing had been constructed over piles to support above

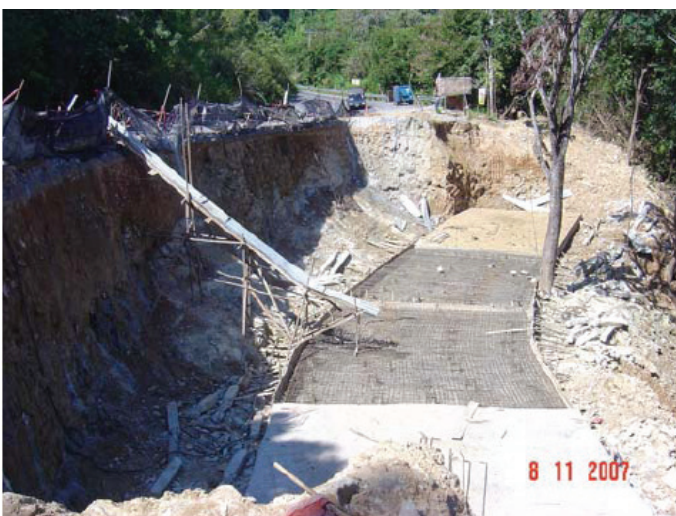
Figure 7: Footing construction.

structure. These footing and piles were used to ensure the above structure that support road repair structure would lay on firm layer.

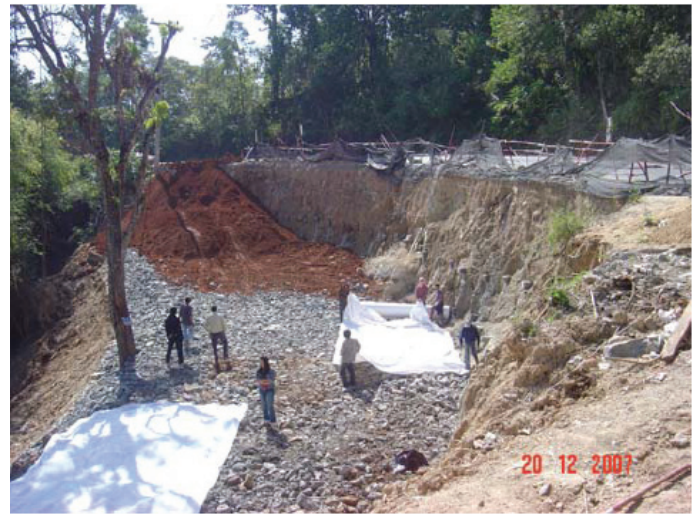
Figure 8: Drainage layer construction.

For the reinforced structure, 1-m of crushed rock was laid on lowest of structure to be drainage layer. 0.50 m-thickness of sand was used for drainage blanket between reinforced structure and existing soil. Drainage layer and blanket would relief the water pressure from saturated soil when occurred rainfall. Both drainage layer and blanket were sandwiched with non-woven geotextile, Polyfelt® PS140, for separation between rock, sand and existing, backfill fined grain soil.

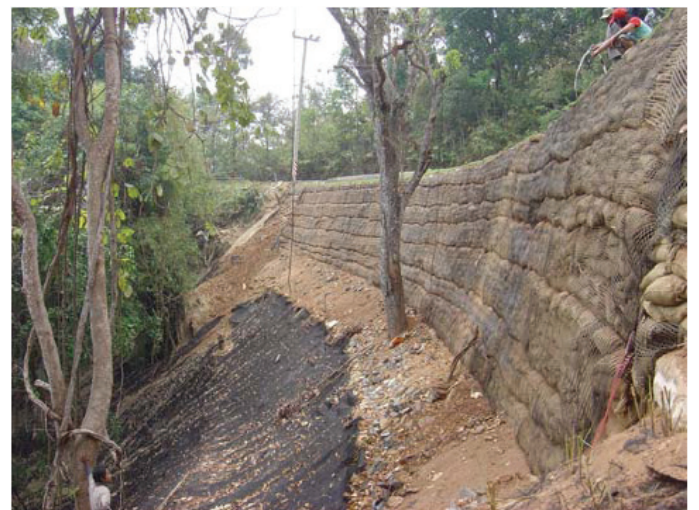
Figure 9: Geogrid (Miragrid®GX) reinforced slope and Erosion control mat (Polyfelt®Polymat) construction.

Third step, problem of limited space of repairing was solved by soil reinforcement. 5-m height embankment was reinforced by geogrid to repair failure road and make steep slope under limited space condition. 10 layers of 5-m anchorage length

uniaxial geogrid by Miragrid® GX 100/30 were used for major reinforcement and 10 layers of 1.5-m anchorage length biaxial geogrid by Miragrid® GX 80/80 were used for minor reinforcement.

When finished main solutions for failure road repairing, the preventing solution of landslide in the future was using the erosion control mat, Polyfelt® Polymat EM4 were used to prevent erosion of rainfall and runoff water that may erode soil surface and make landslide in the future. The erosion control mat was laid from bottom of footing trough to lower road.

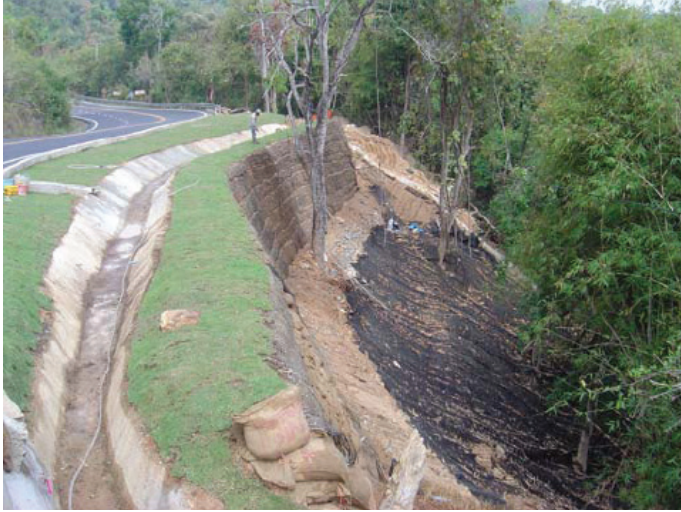
Figure 10: Finish project.
