# Stability of Road Embankment Adjacent Canal in Rural Road Network

**ABSTRACT:** This study focuses in the road embankment stability which beside irrigation canal of Department of Rural Road (DOR) in 3 provinces at central of Thailand (Ayutthaya, Pathumthani, Chacheongsao). The almost of rural roads are used for community transported that low traffic volume and rare heavy load. DOR has 92 road embankments with 1,203 kilometers road networks in 3 study province. The most at risk 9 roads are selected from preliminary survey with 4 criteria: close by canal, tension crack detected, used to failure and narrow right of way. The main study for 9 embankment are soil investigation and geometry survey for 5 sections in each embankment road, The slope stability analyses are perform for 45 sections by PLAXIS finite element program, The factor of safety from analyses are found between 1.5-2.0. Some sections were slope failure or high differential settlement. The analysis results show that the stabilities of embankment are slightly low for normal situation. The embankment probably toward to failure when the rapid drawn-down of adjacent canal occurred or the heavy traffic load was placed.

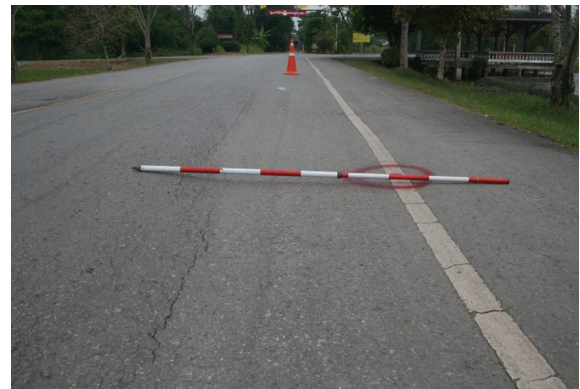
The details for each type were described as follows. In type 1, the damage was found in high settlement of embankment or differential settlement of cross section. This settlement can be noticed the rough surface from the top layer of embankment. The water can be storage in this difference level and seepage to subsoil below caused of softening of embankment and foundation soil. Subsequently, the problems and damages are expanded and affect to road utilization as shown in Figure 3.

Figure 3: High settlement damage type.

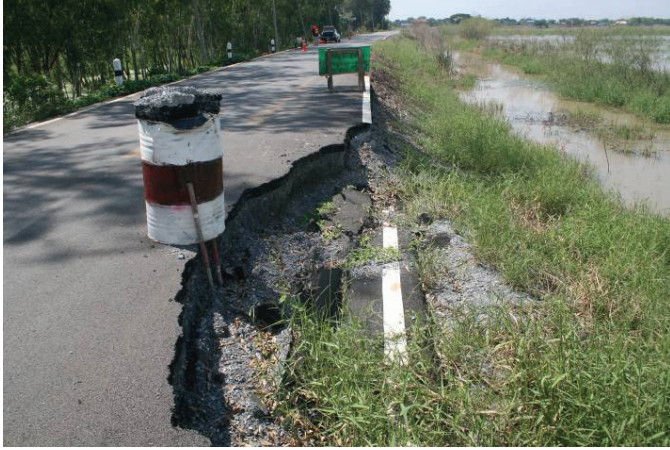
The damage type 2 is failure from slope stability. The typical cross section at before and after of failure is shown in Figure 4. Early stage of this damage notified by tension crack at surface of road embankment and continued increasing of width and length. The embankment body collapsed down and occurred the heave at embankment toe in final stage as shown in Figure 5 from investigation data.

Figure 5: Slope failure of embankment.

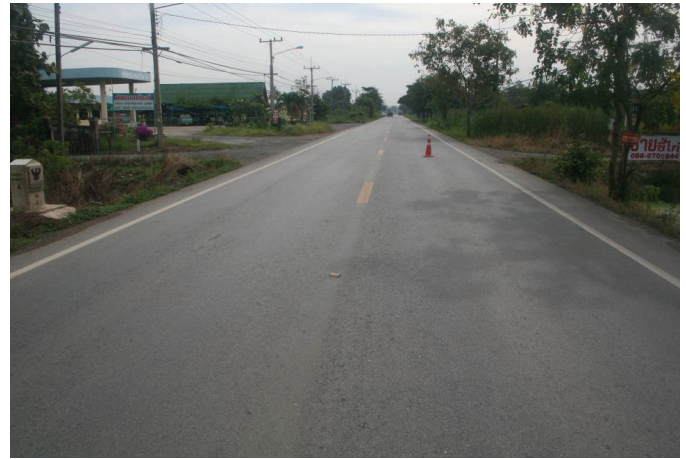
*Level A : Good Condition.* In this level, the embankment including road surface have been good characteristic. There were no destructions or damage in very small scale to observe. For example, hair crack on road surface or very tiny erosion at slope of embankment were not detected by visual investigation and traffic serviceability still in safe condition for users. The road embankment in good condition is shown as Figure 6. Road in good condition no require the repairing but the period monitored of damage progressive still required.

Figure 6: Road in Level A : Good condition.

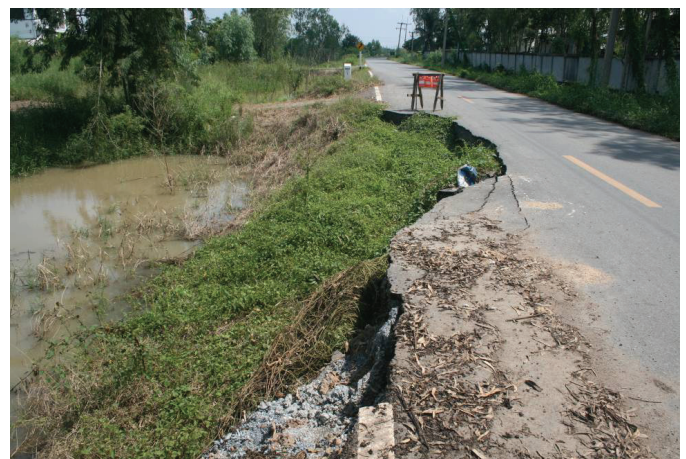
*Level C : Poor Condition.* The differential settlement of fracture and crack can be clearly observed in this level. The tendency of damage progressive may be appeared. In some case, the embankment damage was extremely unstable or collapse through out of service traffic area as shown in Figure 8. The damage of this level was in danger to road user which must be immediately restabilized and restore the embankment to safely condition.

Figure 8: Road in Level C : Poor condition.
