Long Term Performance Monitoring of a Reinforced Soil Structure Constructed over a Reclaimed Sewage Pond

Lee, E.C.

Emas Kiara Geo Services Sdn Bhd, Malaysia

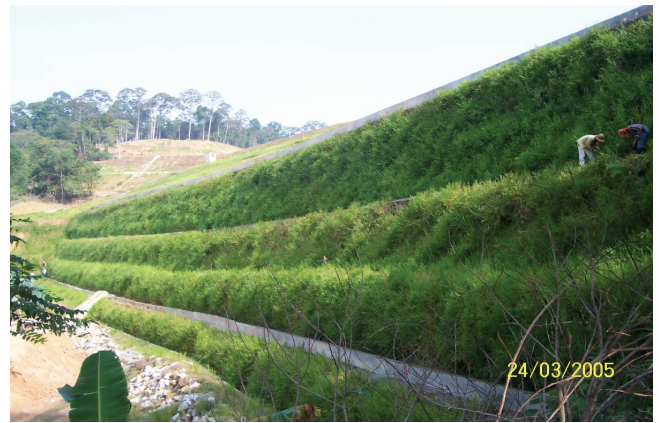
Figure 3: A view of a completed section of the structure.

Figures 3 and 4 show visuals of the completed structure. As shown in the figure the facing of the structure was hydroseeded.

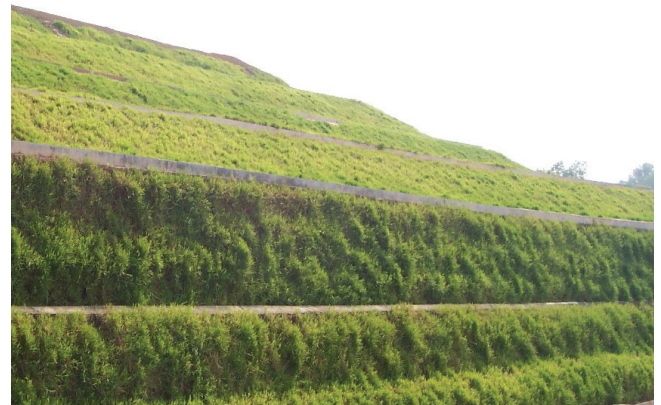
Figure 4: A view of another section of the completed structure.
