A STUDY OF DEFORMATION BEHAVIOUR OF AN INSTRUMENTED SLOPE SUBJECT TO RAINFALL NEAR THADAN DAM THAILAND

ABSTRACT : A methodology has been developed using DACSAR Finite Element programme to predict the deformation of soil slope subjected to known pore water pressure distributions. Field monitoring results of pore water pressure and shear strains within the soil slope near Thadan dam, Nakornnayok Thailand during May 2008 until October 2008 have been used to validate such method. In the simulation, Drucker-Prager constitutive model is assumed for the slope material based on compression and shearing behaviour from consolidated drained direct shear tests. Several assumptions have been made in order to specify the hydraulic conditions for all elements at each step. Firstly, only positive pore water pressure is used and negative pore pressure is neglected in the analysis (pore water pressure assumed to be zero if negative). Secondly, the pore water coefficient, r_u is used to generalize spatial distribution of the pore water pressure from point-wise measurement. The Young's modulus, Poisson ratio, and initial coefficient of earth pressure have been estimated based on the results of direct

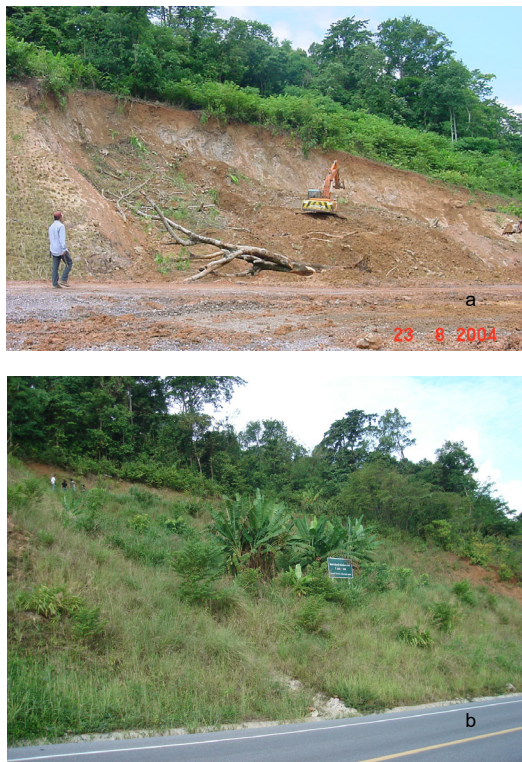
Figure 1 The studied slope (a) in 2004, after failure (b) in current state after regrading and vetiver grassing

In order to gain more in-depth understanding of the actual slope behaviour subjected to rainfall, Jotisankasa & Porlila (2008) developed a slope monitoring system, consisting of MEMs tensiometer/piezometer for pore water pressure measurement (Jotisankasa et al., 2007) and MEMs inclinometer for shear strains. The prototype monitoring system has been installed since May 2007 in a slope of failed soil mass that had been re-graded in 2004

(Figure 1). Slope failure in 2004 was triggered by an intense rainstorm which amounted to about 300mm in three days. The slope is situated in Nakornnayok province, east of the central region, where the geology consists of undifferentiated Permo-triassic volcanics rocks, including rhyolite, andesite, tuffs, and agglomerate (Royal Irrigation Department, 2004). The material on the slope is classified as medium plasticity silts (MH/ML) with basic properties summarized in Table 1. Jotisankasa (2008) carried out detailed studies of the material properties including, shear strength-suction relationships, soil-water characteristic curves and field infiltrability.

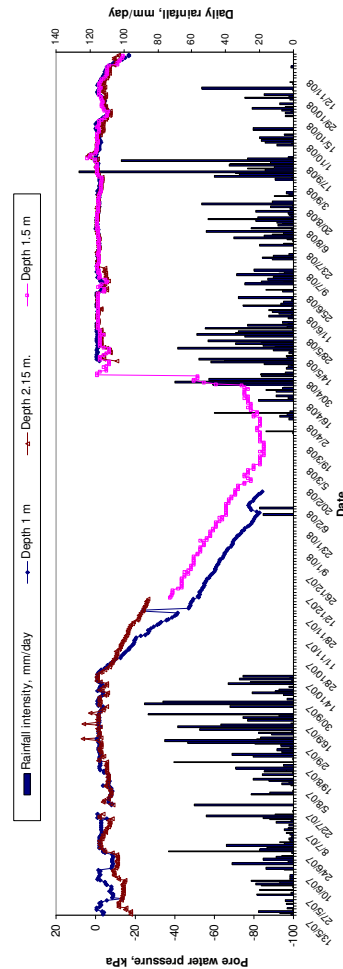
Figure 3 Pore water pressure (point 1) and rainfall during 2007-2008 monitoring period

Figure 3 shows the overall results of pore water pressure and rainfall over 1.5 year period. The correspondence between the pore water pressure and rainfall is evident, whereby pore water pressure became progressively more negative during the dry season as evapo-transpiration continued without rainfall. During rainy season, however, the pore water pressure became close to zero and at times become positive after intense rainstorm (greater than ~100 mm/day). The degree of tilting from inclinometer remained relatively unchanged until a heavy rainfall (~230mm) in the week of 13-19 September 2008, when the pulses of tilting, as well as surges in pore water pressure were observed. In this respect, Finite Element analysis using DACSAR-M programme (Iizuka & Ohta, 1987, and Takeyama et al., 2006) were performed, based on the monitored pore water pressure values as input data, in order to reproduce the deformation of the soil slope that has been observed in the field. The analysis was also used to predict the shear strains when slope undergoes overall failure and used as a criteria for early warning.
