## 2011 Disastrous Landslides at Khao Panom, Krabi, Thailand

Suttisak Soralump

Geotechnical Engineering Research and Development Center (GERD)

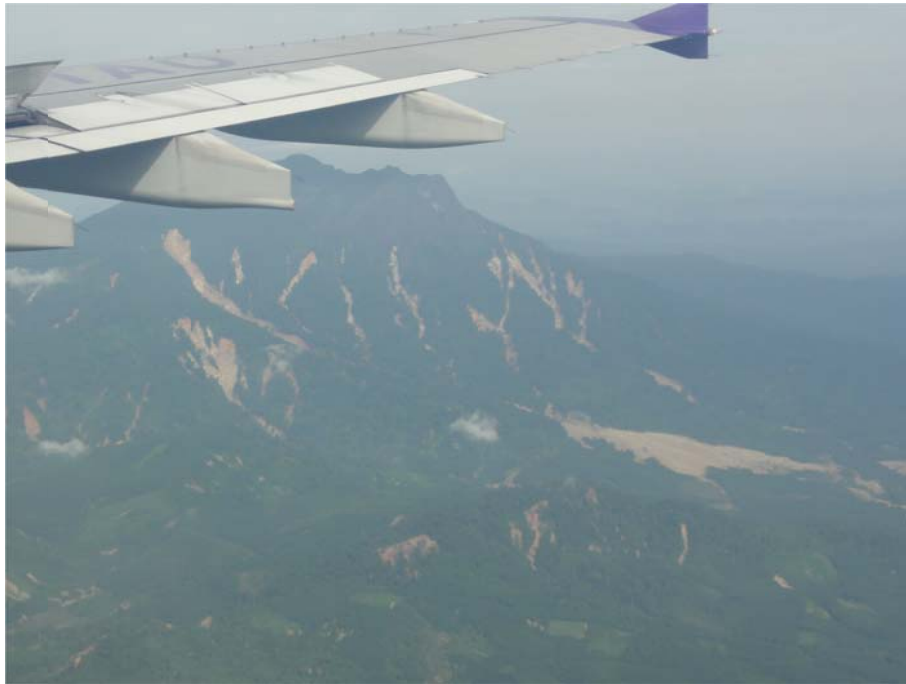
Figure 1. 28<sup>th</sup> of March 2011 landslide in Khao Panom, Krabi province

Near the end of March 2011, the heavy storm has hit the eastern part of the mountain. Three sub-watersheds have suffered with large precipitation and finally the debris flows has occurred on the 28<sup>th</sup> of March (Fig 2). The accumulate precipitation of over 1,200 mm was unofficially reported by the cup-type rain gauge in which recorded by the villagers. Large granitic boulders of up to 10 meter in size were found at 2 km from the landslide sources (Fig 4). These granite boulders have tremendous energy and force in which destroyed the houses and man-made structures in their path.

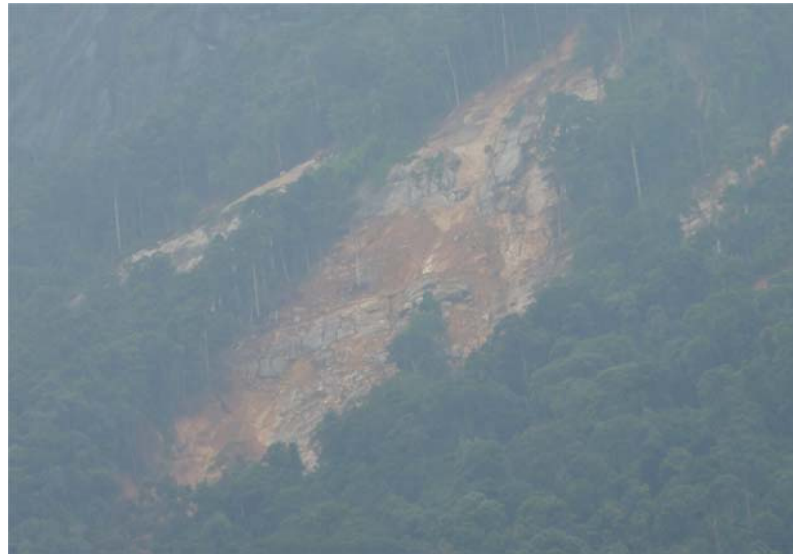
Figure 6. Landslide scars on granitic rock.

From the developed map, it is found that the landslide location occurred in 2011 is located in a high landslide susceptibility zone. This is because of southern granite is the rock that most susceptible to cause landslide in Thailand (Soralump, 2010). During the field investigation in Khao Panom after the landslide has occurred, the landslide scars were found mostly in granitic mountain (Fig 6). Some scars were observed in sedimentary rock surrounded but those scars are look more like erosion rather than the slope failure. However, further investigate need to be done in order to understand the behavior of this landslide.

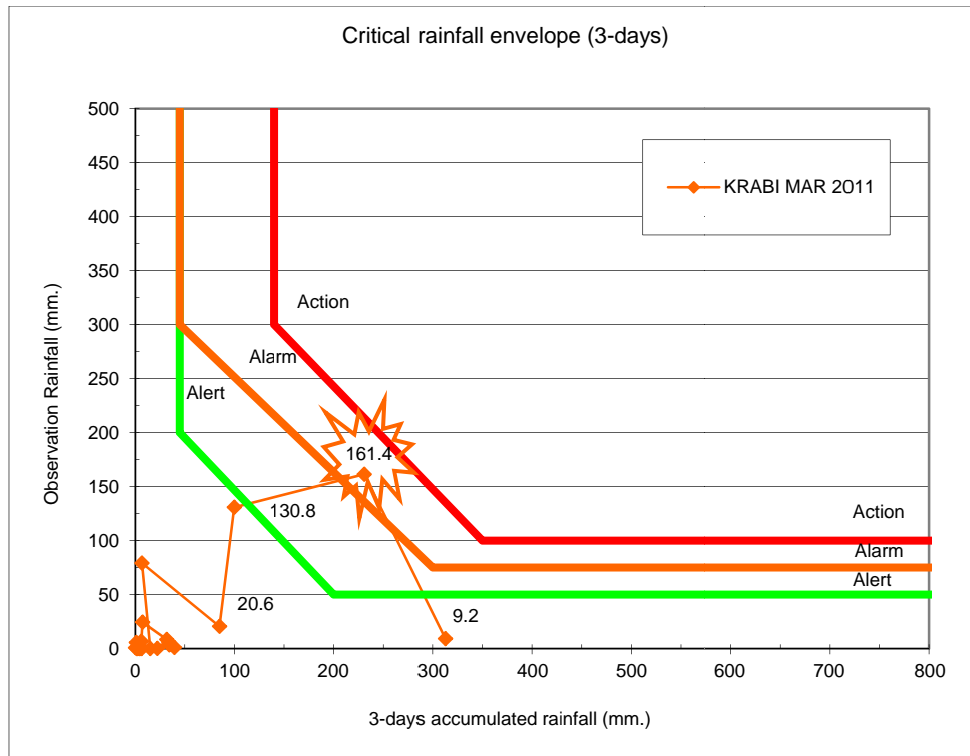
Figure 8. Daily rainfall and 3-days accumulated rainfall plotted using 28<sup>th</sup> of March 2011 rainfall data and comparing with the landslide criteria.

By collecting the rainfall data (before and during the 28<sup>th</sup> of March 2011, Fig 7) from various rain gauge stations, the data were used to plot and compare with the critical rainfall envelop made by statistical data by Prof. Warakorn Mairaing. 3 days accumulated rainfall was used to plot with daily rainfall data. From Fig 8, it can be seen that landslide had occurred before the plotted data has reached the critical zone (action criterion line). The problem with this prediction is because of the location of rain gauge stations are not located near the landslide area (Fig 9). This is because of the landslide area is in the remote location where the communication of the data could not be provided. This is one of the major problems of landslide warning system in Thailand. Therefore, in those remote areas the cup-type rain gauges were distributed to the residence people. DMR issued the rough but effective criterion of critical rainfall to be used with the cup-type rain gauge. The evacuation will be issued if the precipitation is recorded to be 150mm per day. Furthermore, if precipitation is recorded to be more than 300mm in a few days the preparation for evacuation must be done. Therefore, with those criteria, during the debris flow event in March 28<sup>th</sup> the residence was self- warned and evacuated themselves to the safer ground.
