Application of Wrap-Around Reinforced Structure at Hilly Road Repair Case in Thailand & Taiwan

Amie Wang, Nana Chen, Pei Hsuan Wu & Chin Ming Chang
ACE Geosynthetics Co., Ltd. Taichung, Taiwan

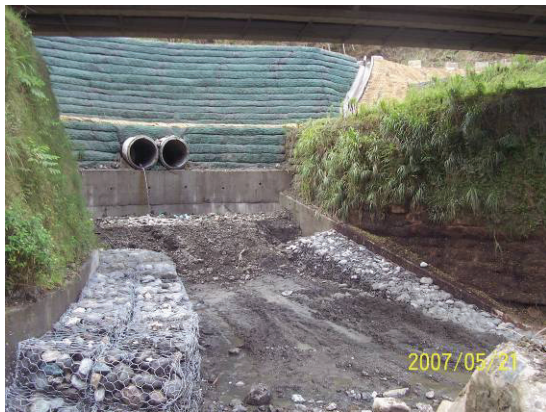
Reinforced structure is composed of soil and reinforced material primarily, appreciated drainage system, including interior and exterior systems, are needed according to the site conditions to prevent the effect of erosion by the rainfall of torrential rain. Soil bag with gravel, drainage board and drainage sheet are the common materials for interior drainage system helping eliminate the seepage from original slope in the rear of reinforced structure. Exterior drainage system is usually made of concrete or shotcrete method on the top and surface of slope structure. Drainage culvert is suggested to protect soil from weakening caused by infiltration providing that underflow and culvert are found during the excavation. (see Figure 12)

Figure 11: Drainage system.

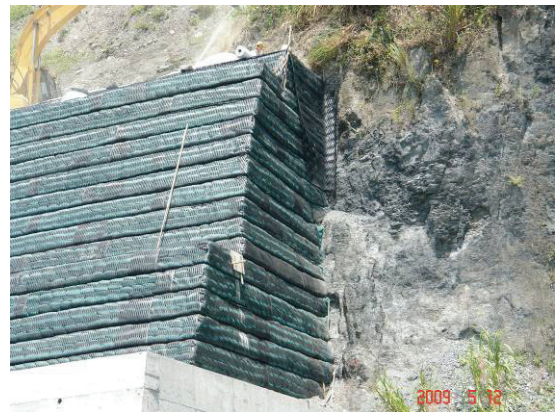
During construction, the installation problem commonly forms on the boundary between original soil layer and the both sides of the reinforced structure. The designer may consider adopting longitudinal ditch or wrap-around facing - which extends 1.5 ~ 2 meters in length into the structure - at the interface to this problem. This design is to avoid erosion problem caused by new drainage channel which occurs at the interface during torrential rain. (see Figure 13)

Figure 12: Lateral construction.
