Cyclic drawdown of water causing the slope failure of canal and dam

Suttisak Soralump¹, P.W. Noppadol², K. Panthi³ and J. Sanmuang⁴

1 INTRODUCTION

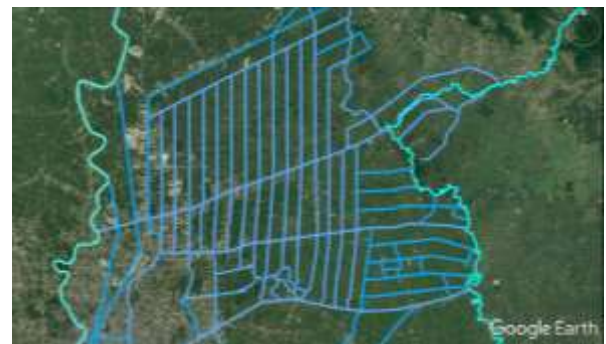
Lower Chao Phya basin consist of marine clay deposit called Bangkok soft clay which thickness of 8-12m. These area are suitable for rice production and are in need of irrigation canal to supply water all year round. These canals were built systematically in this area as shown in Figure 5 and later was modified to be a foundation of road embankment (Figure 6).

Figure 5 : Systematic Canal located at Lower Chao Phya Basin

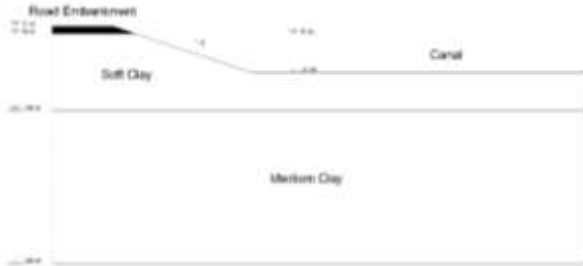
Figure 6: Road Embankment Foundation
