## Static and seismic performance of Mae Suai dam and its remedial works

Suttisak Soralump

Associate Professor, Dam Safety Research Unit, Geotechnical Engineering Research and development center,

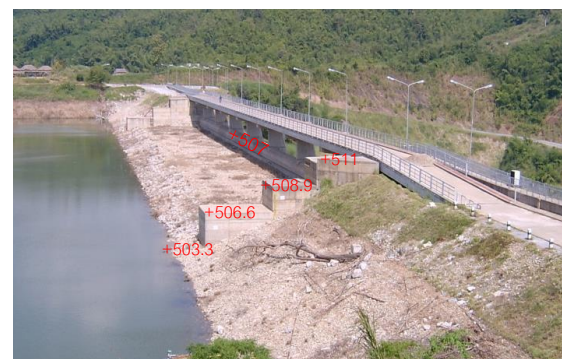
Figure 3 Guide wall

To prevent the erosion to the earth filled part when the spillway is overtopped, the RCC block has been constructed as a water guide wall as shown in Fig 3. These blocks is placed directly over the earth filled material.
