Technical Paper

Assessment of the upstream slope failure of a dam due to repeated cyclic drawdown

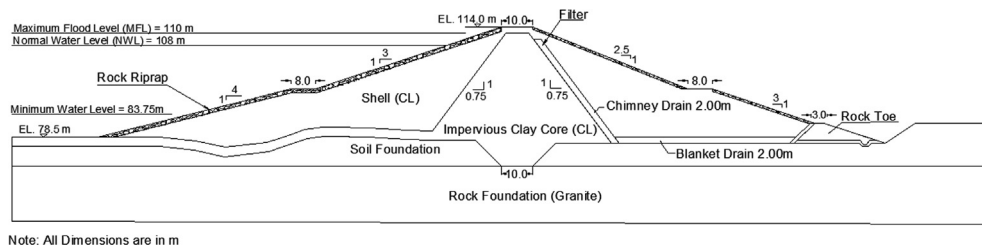
Khlong Pa Bon Dam is a 45 m high embankment structure with a length of 750 m and a reservoir capacity of 20 million cubic meters (Soralump et al. 2019). The dam is laid on a granite rock foundation with an overburden soil consisting of impervious residual soil. The dam body consists of an impervious clay core, shell zone, boulder riprap, and filter material. The impervious clay core consists of low plastic clay (CL), whereas the shell zone consists of silty clay with gravel. Gravelly clay and sandy clay are present in the soil foundation. A chimney drain and blanket drain are included to allow drainage of water from the clay core and prevent the downstream slope from becoming saturated. The cross-section of the Khlong Pa Bon Dam is shown in Fig. 1.

Fig. 1. Cross section of the Khlong Pa Bon Dam (0 + 297 m).

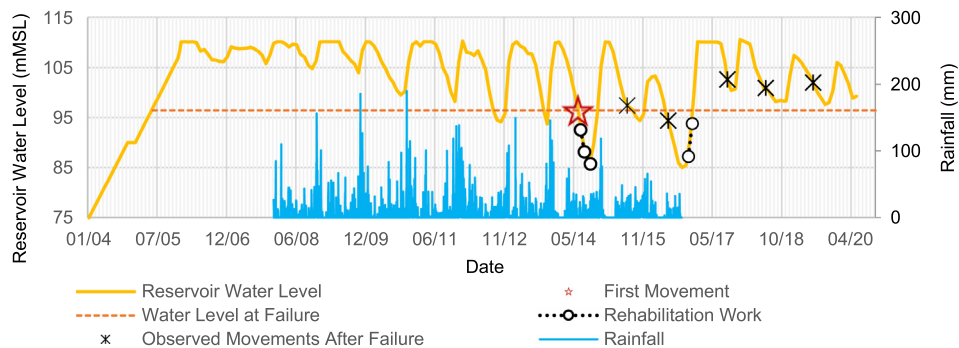
In 2014, the dam underwent a drawdown of 24.22 m in 241 d, resulting in the lowest water level ever observed in the reservoir. It was hypothesized that this drawdown was the major cause of the upstream slope movement. During a site inspection, a vertical movement of 2 m was observed at the failure zone along the 80 m length (Fig. 2 and Fig. 3). In the hydrograph of Khlong Pa Bon Dam, it can be observed that the movement occurred when the water level was 96.45 m (Fig. 4), while no movement was observed in 2013 when the minimum water level was 93.13 m (Table 1). If the failure occurred due to RDD, this raises the important question of why no movement occurred in 2013. The drawdown of the water level in the Khlong Pa Bon Dam is summarized in Table 1.

Fig. 4. Rainfall, hydrograph, and timeline of the Khlong Pa Bon Dam.

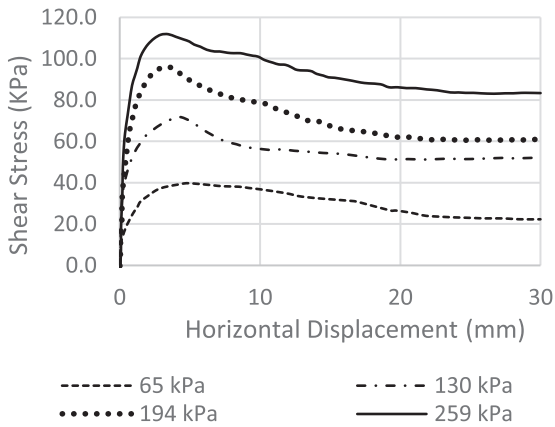
The investigation was based on the assumption that the strength of the soil was reduced from the peak to the residual value at the time of failure. Thus, the residual strength of the slope was determined from reversal direct shear tests (Fig. 9) and ring shear tests (Fig. 10). The normal stresses used in the laboratory tests ranged from 25 kPa to 300 kPa, which is within the normal stress range of the failure zone, i.e., 0–160 kPa. Laboratory tests were conducted to simulate the exact site conditions. The methods used for the reversal direct shear tests and ring shear tests were based on previous tests conducted by multiple researchers (Stark and Hussain 2010; Suzuki, Tsuzuki, and

Fig. 9. Results of reversal direct shear tests on the failure slope.

The shear stresses obtained from the reversal direct shear tests were compared with the results obtained from the MCC model with the passage of time at the failure zone. A normal stress of 65 kPa was applied to the soil sample obtained from the failure zone to determine the residual shear strength (Fig. 9). Furthermore, the shear stress was determined at point X (Fig. 14) from the numerical analysis with a normal stress of 65 kPa and compared with the result obtained from the direct shear test (Fig. 17). The results show a reduction in shear stress in both the lab-

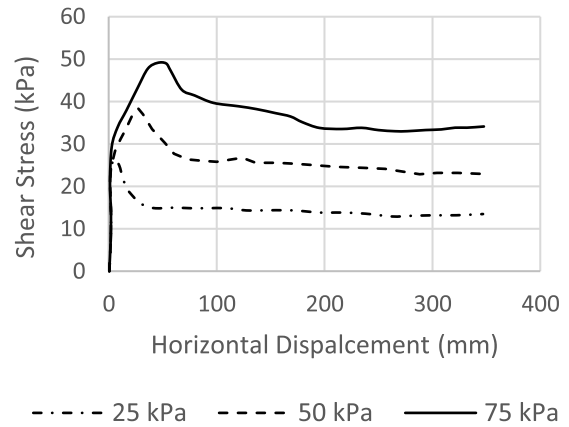
Fig. 10. Results of ring shear tests on the failure slope.

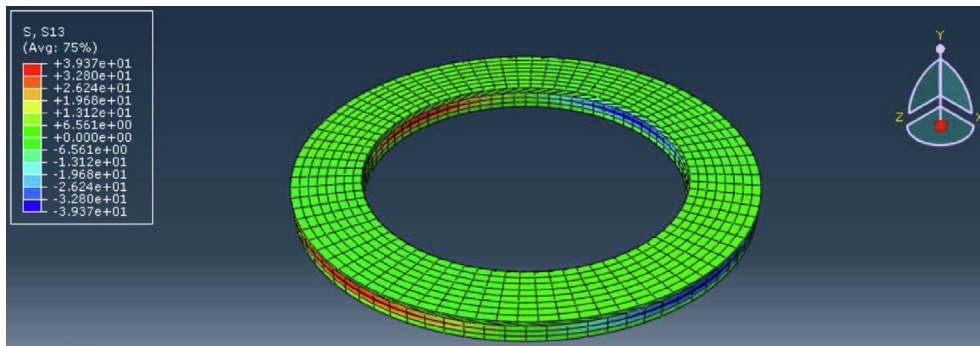
Fig. 11. 3D simulation of a ring shear test in ABAQUS.

shear rate of 0.25°/min. A 3D simulation of a ring shear test in ABAQUS is shown in Fig. 11.

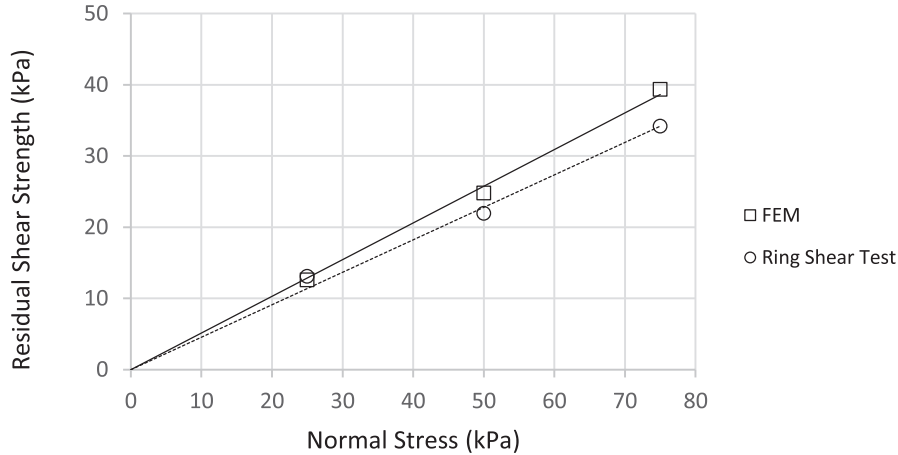
The residual shear strengths obtained from the ring shear tests are compared with the results obtained from the FEM in ABAQUS in Table 5 and the results are also plotted in Fig. 12. The numerical analysis was conducted under the same conditions as those used in the laboratory test for a fair comparison. The results obtained from the FEM are in good agreement with the results of the laboratory tests, as shown in Fig. 12

Fig. 12. Relationship between the residual shear strength and normal stress.

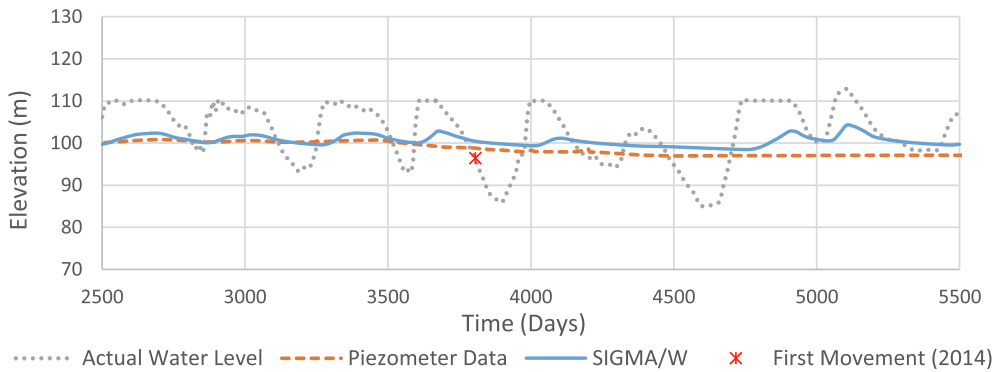
The results from the transient seepage analysis were compared with results obtained from 14 standpipe piezometers located at 0 + 130 m. The instrumentation results for the total head from piezometer number 10 (PZ10) and SEEP/W for 2500 d to 5000 d are shown in Fig. 13. Because the permeability of the clay core is very low, no significant variation in the water level was observed in the piezometer with fluctuation of the water level. This behavior was observed for all of the piezometers installed in the clay core (Panthi and Soralump 2020). Furthermore,

Fig. 13. Comparison of water levels: actual level, piezometer data, and SEEP/W results.

The Khlong Pa Bon Dam experienced significant drawdown for three consecutive years (2012–2014) following two smaller drawdowns (2010–2011). The piezometer results also showed that the slope was partially undrained during this period (Fig. 13). Therefore, the shear strength of the soil surpassed the peak strength during these drawdown cycles, changing the soil from the elastic to plastic phase. Furthermore, strain accumulation was also observed after the soil had surpassed the peak strength.

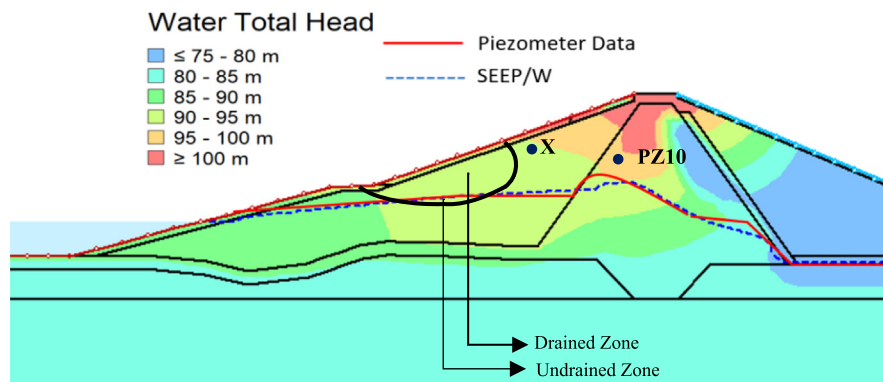
the total water head at the embankment on the 3894th day (minimum water level) from the date of impounding shows that the results obtained from the piezometer and SEEP/W are almost identical (Fig. 14). It was found that the slope was partially undrained after each drawdown.

Fig. 14. Comparison of water levels obtained from the piezometer data and SEEP/W for 0 + 297 m (3894 d).

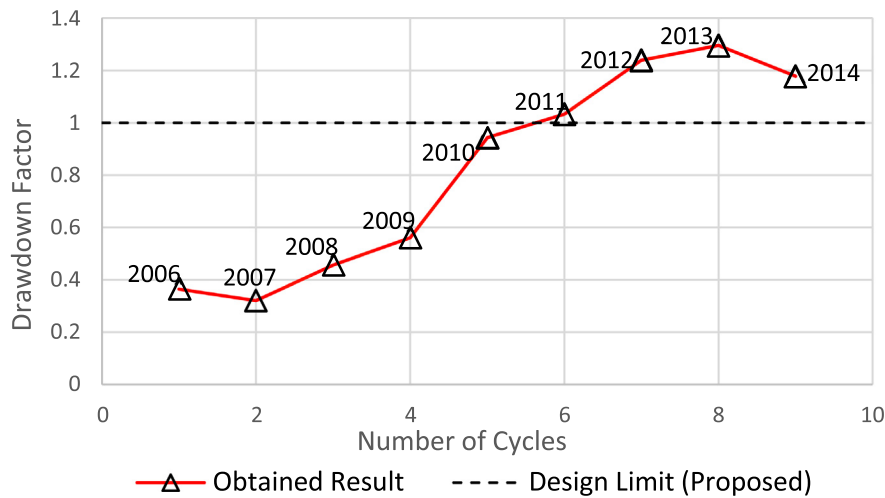
Fig. 16. Variation in the drawdown factor with the number of cycles for Khlong Pa Bon Dam.

relationship between the maximum total stress and maximum shear strain was obtained from the numerical model at point X (Fig. 14). The results show that the upstream slope was in the elastic phase from 2004 to 2010 (Point P) because the shear strain returned to its original state after each drawdown cycle. However, after 2010, the soil surpassed the elastic phase, leading to the accumulation of shear strain (Point Q). With each additional drawdown cycle, the strain accumulated, causing movement of the slope in 2014. The strain–time history curve shows that the strain began to accumulate (Fig. 18) when the drawdown factor was greater than one (Fig. 16).

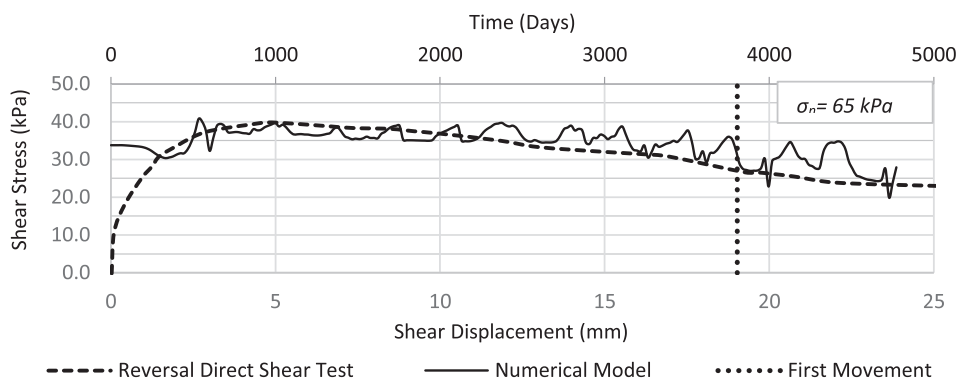
Fig. 17. Comparison of shear stresses obtained in the laboratory tests and numerical modeling.
